Severn Street, Worcester, Worcestershire

Archaeological Evaluation and Watching Brief Report

Ref: 104660.03
July 2014

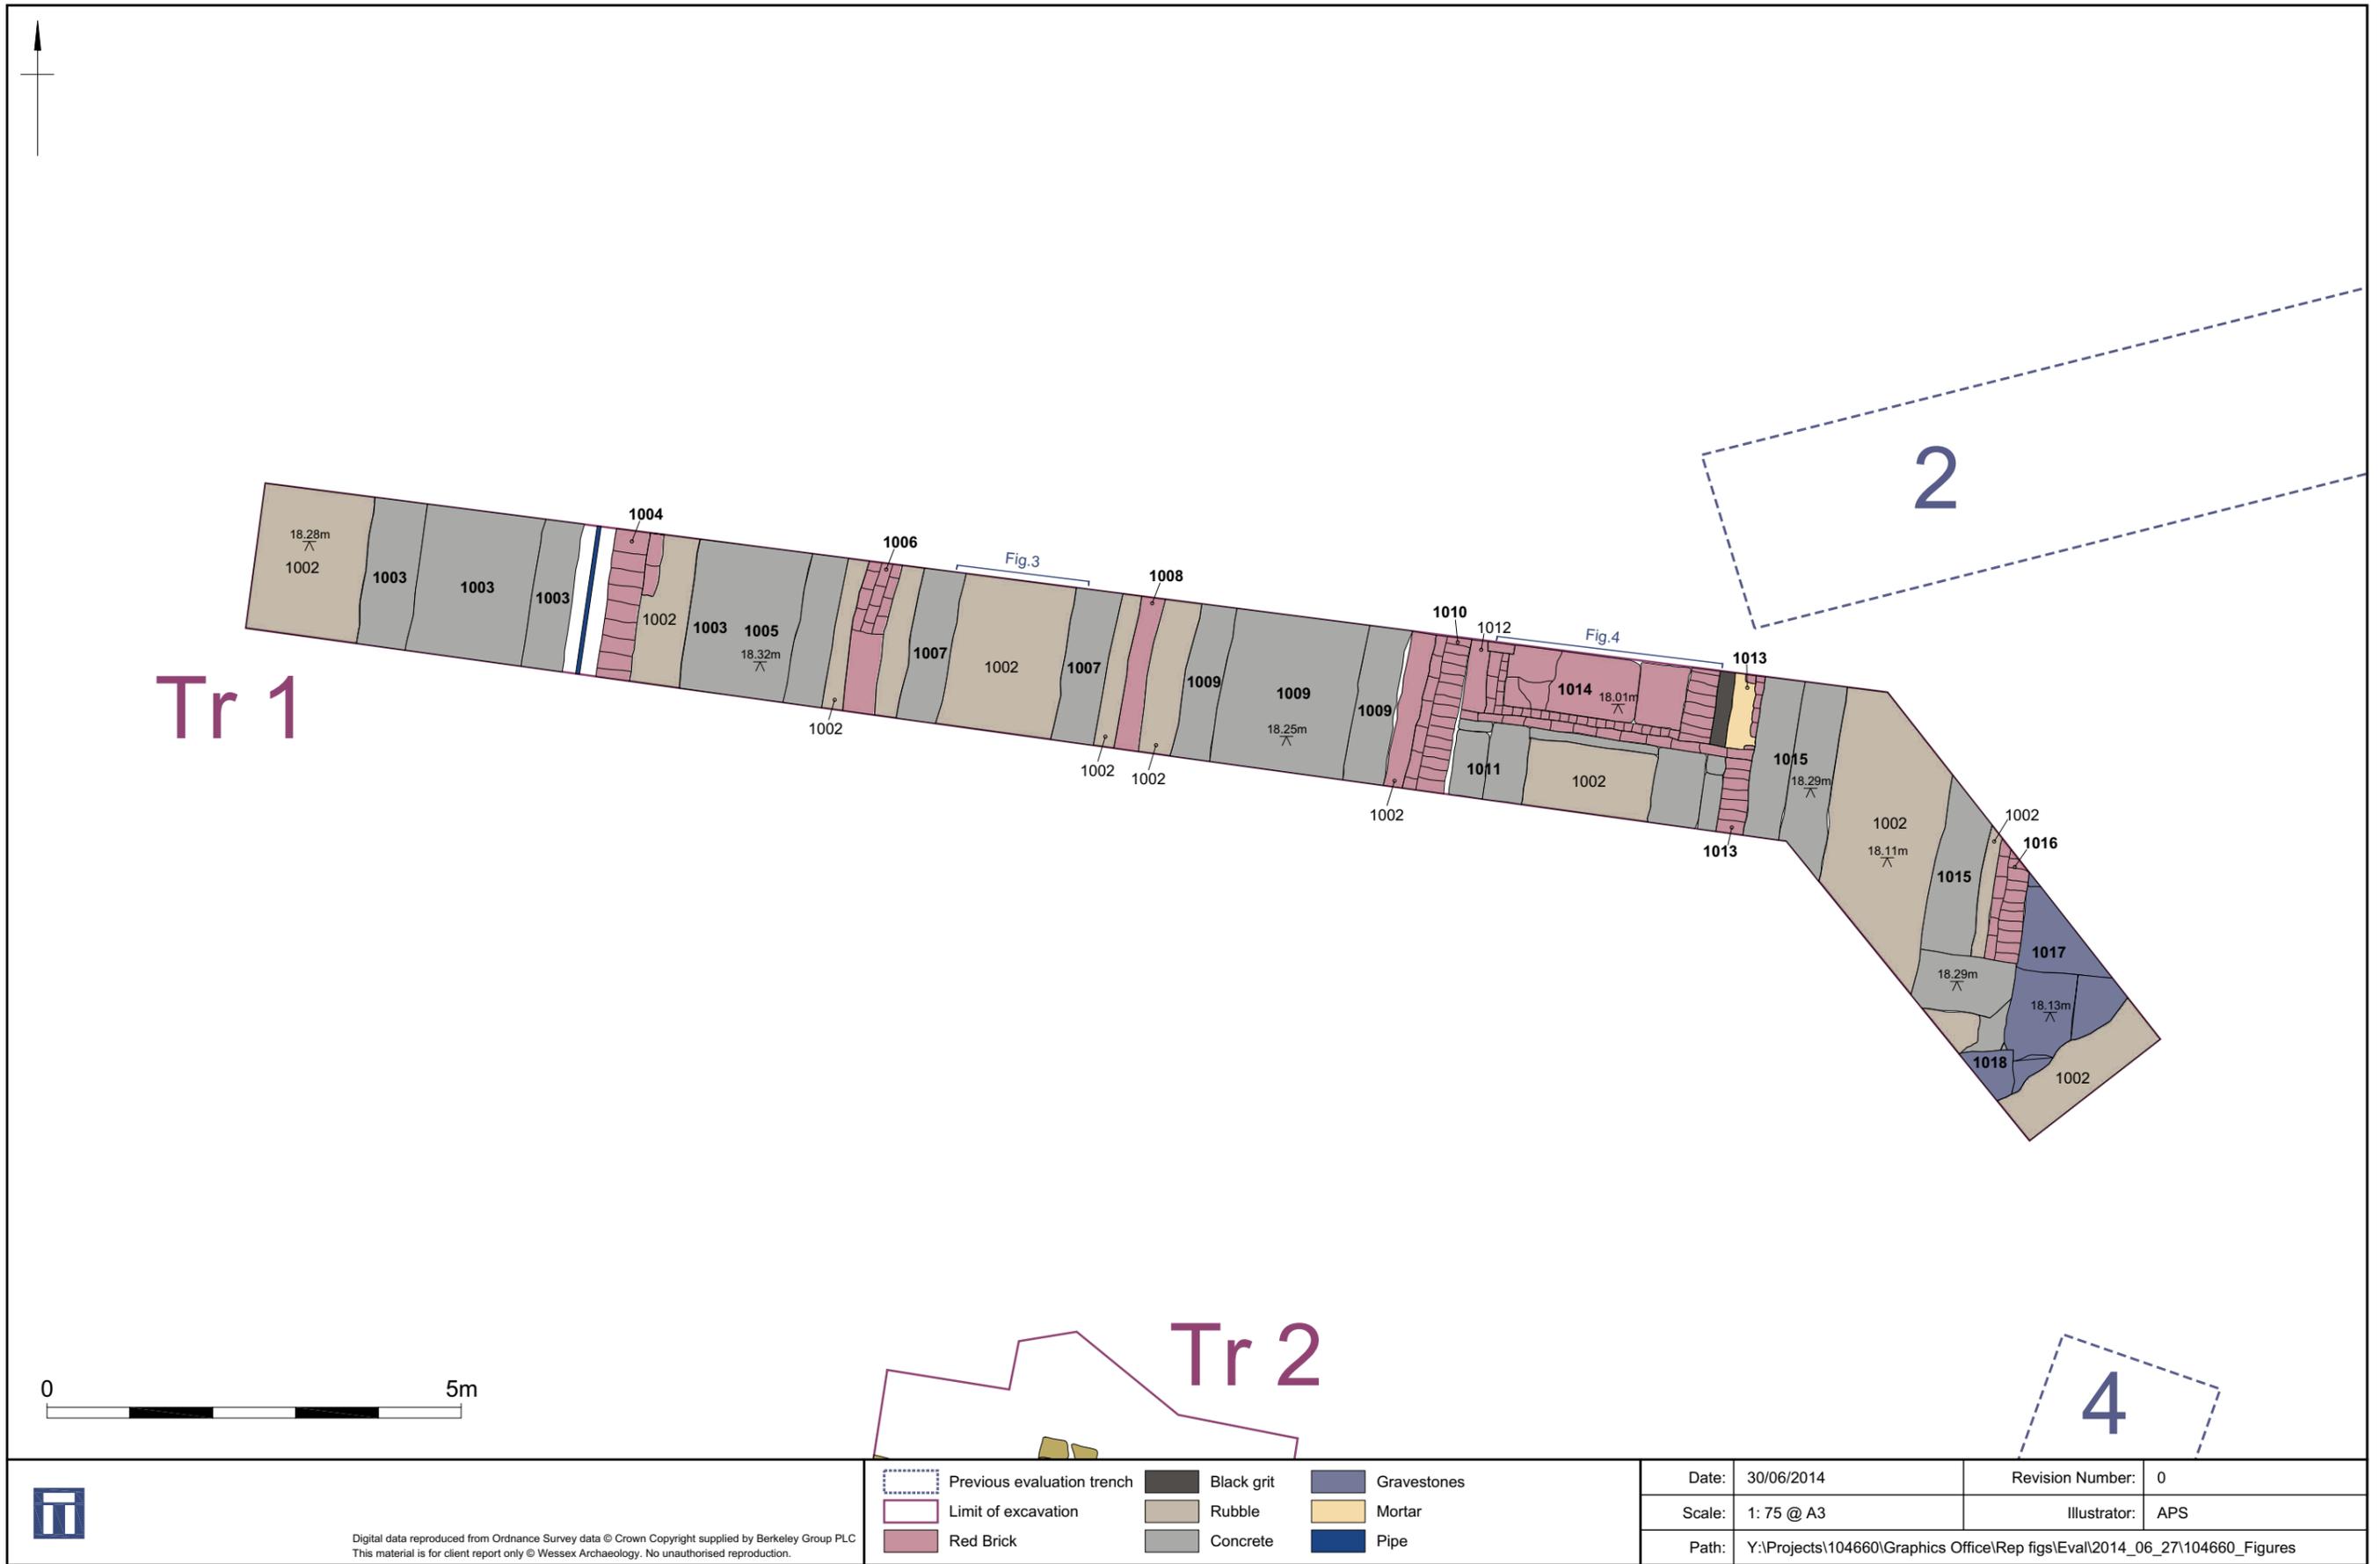
Figure 2

Plan of Trench 1

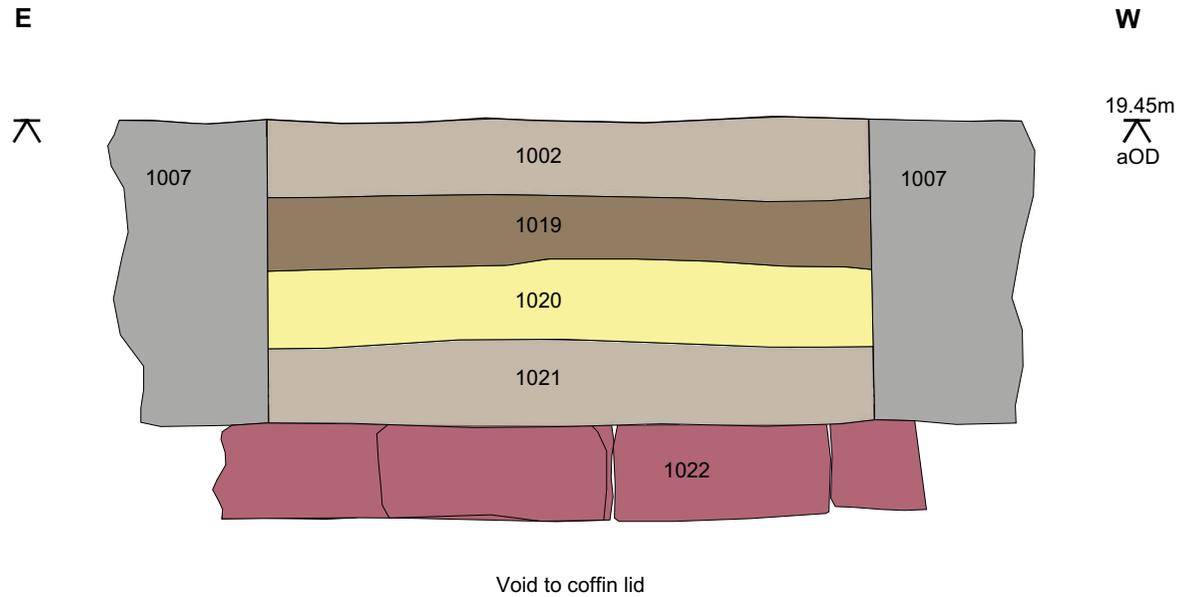
Figure 3

Series of deposits above vault **1022**

1020	Deposit: Black ash deposit containing clinker and fine rust as well as decorated glass and a copper strip. Bedding material.	1.2m
1021	Deposit: Layer of grey brown mixed clay with ash and grit. Made ground over 1022.	1.2m
1022	Structure: Late C19th-C20th Burial vault. Brick built with sandy mortar, vaulted ceiling.	1.2m
1023	Deposit: Mid brown silty clay with brick, lime mortar, stones and ash. Made ground under 1014.	1.2m

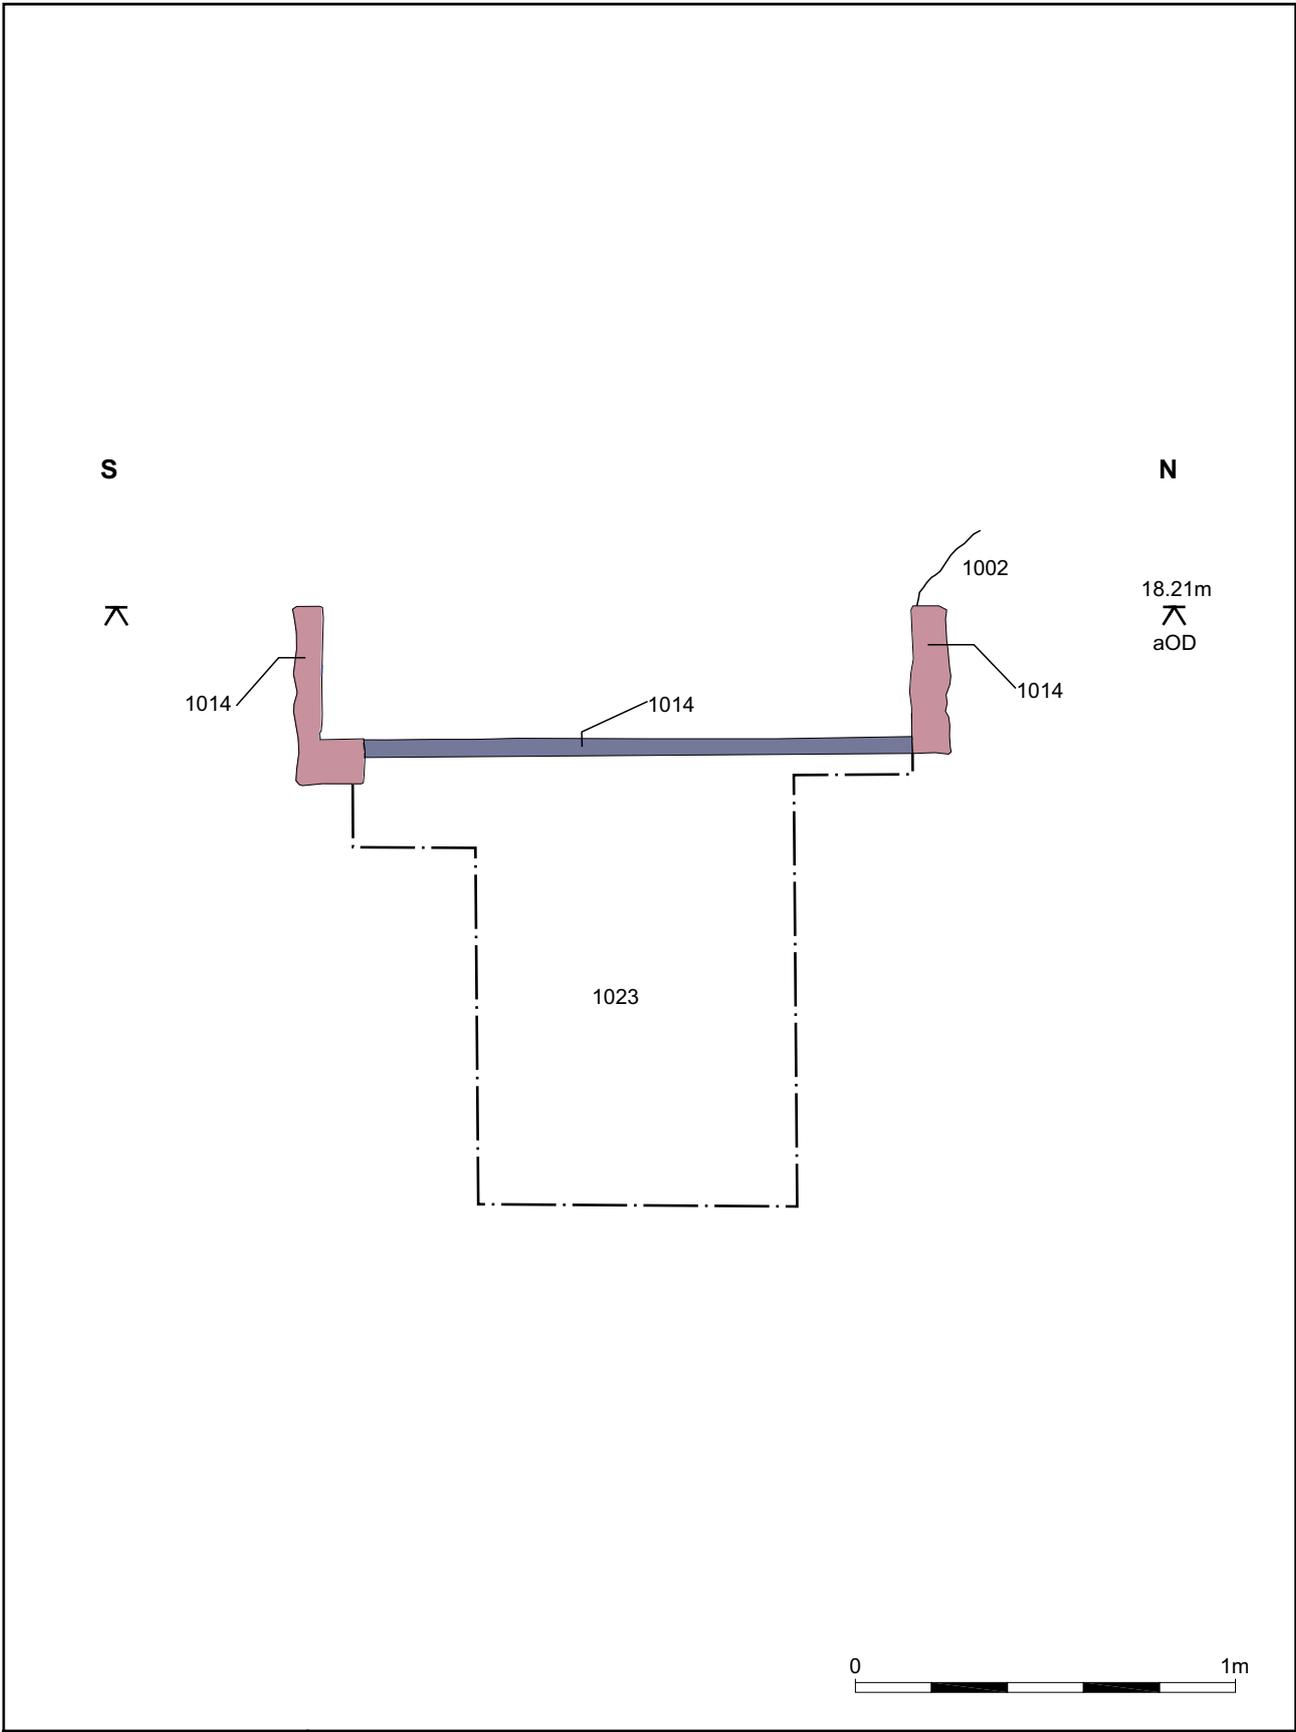
Figure 4

Made ground **1023** beneath structure **1014**

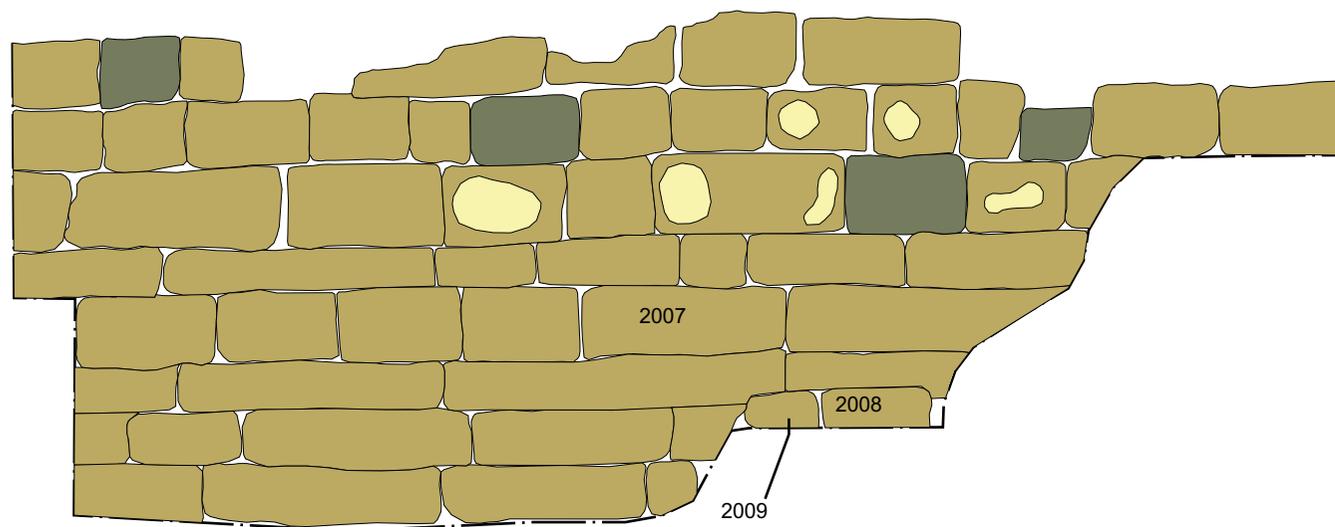
Figure 6

North facing elevation of wall 2007

- 4.4.2 To the north of wall **2007**, a machine sondage was dug. A small square sandstone structure (**2008**, **Figure 5**, **Plate 7**), one course high, abutting **2007** and made of identical materials to **2007**, was seen at a depth of 1.6m BGL. Below this was a soil like made ground (**2009**) similar to that in the rest of the trench. The sondage halted at 2.6m and was immediately backfilled (**Plate 8**). Wall **2007** stepped out into wider foundation courses at 2.5m BGL but the base of **2007** was not reached.

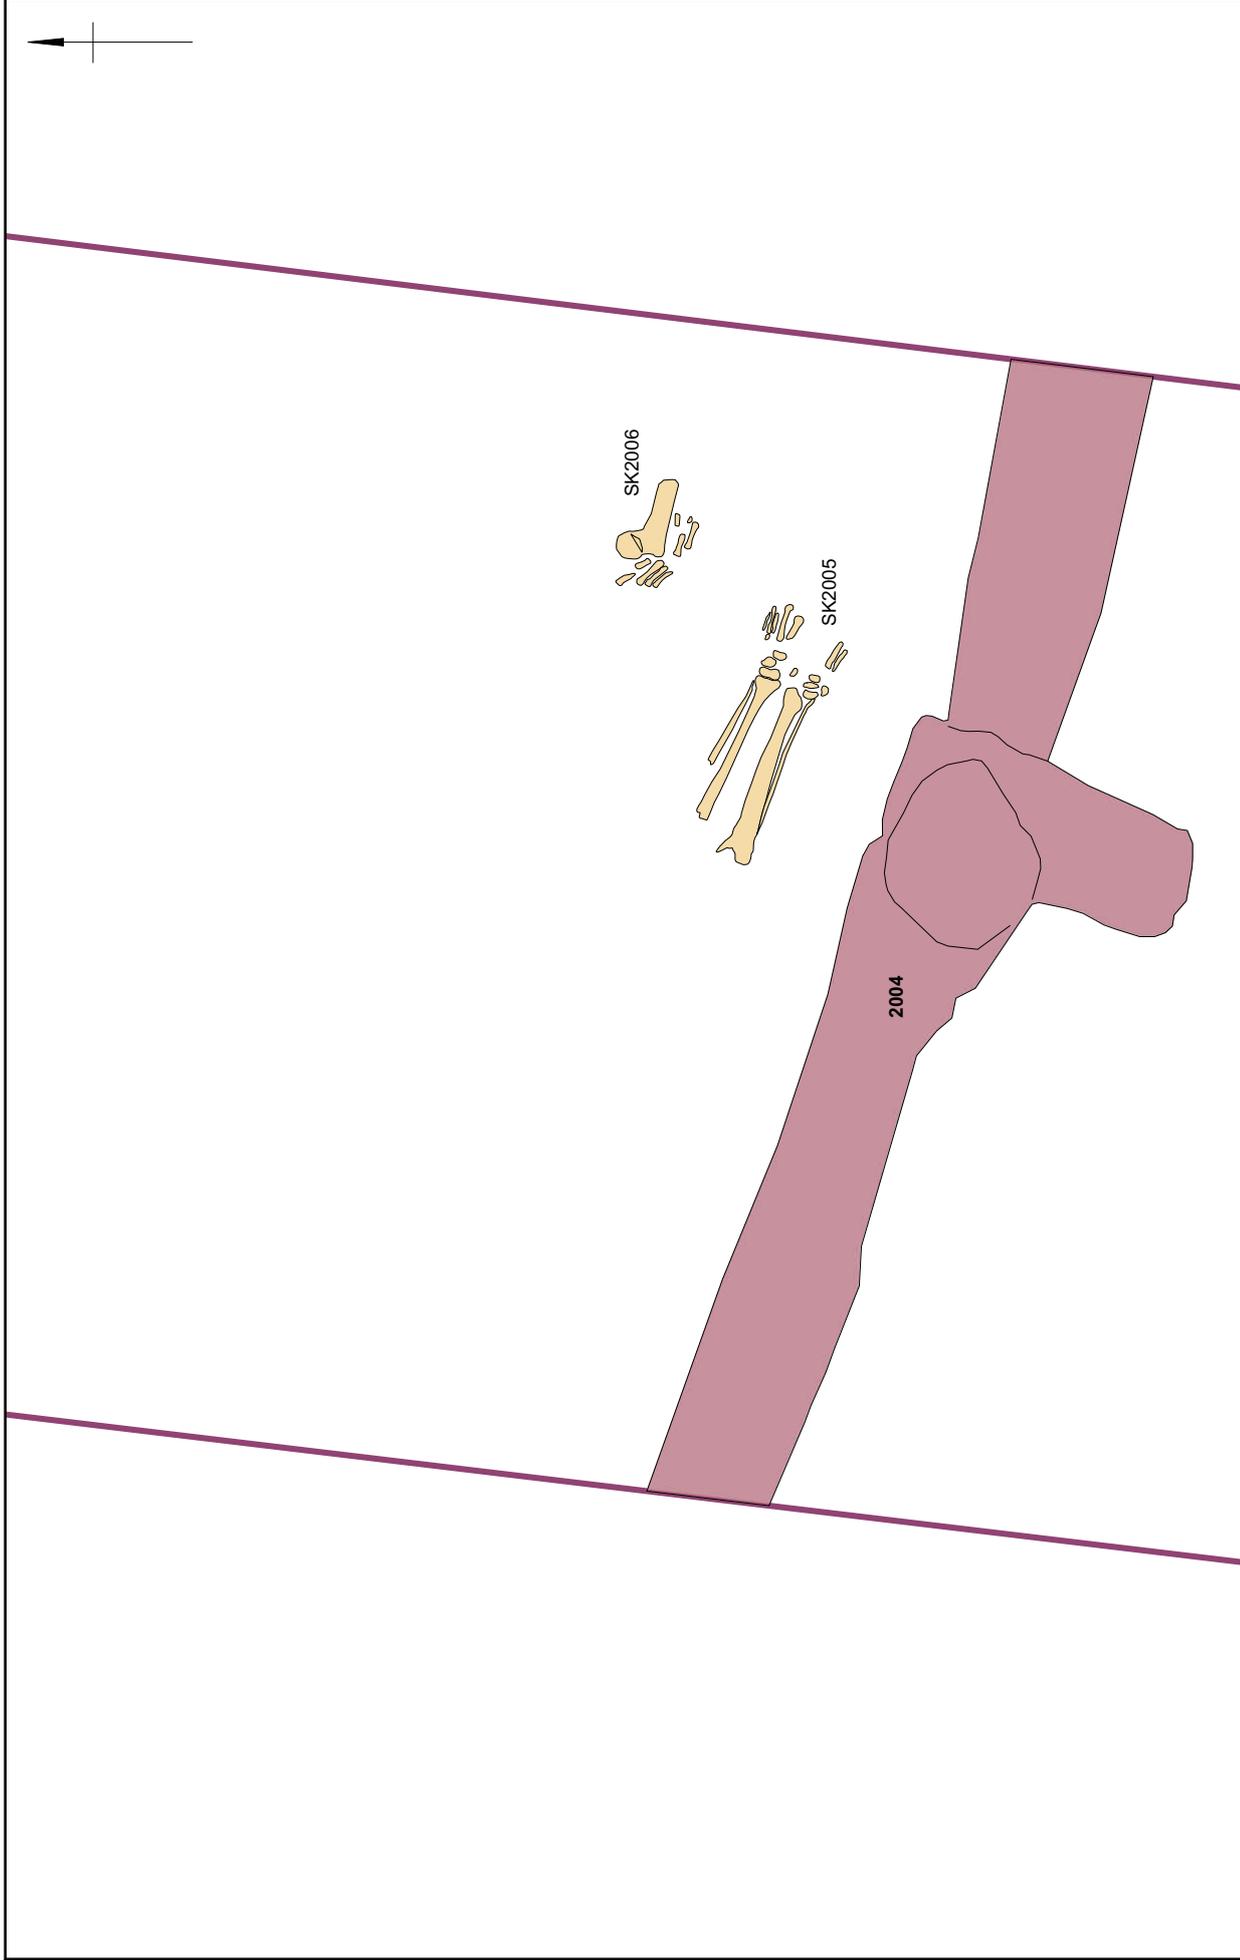
Figure 11

Plan of vault 2004 and skeletons 2004 and 2005

- 4.4.5 In the south part of **Trench 2** was **2004** (**Figure 11, Plate 14**), the truncated remains of a stone tomb or vault. Part of the floor of **2004** remained, as did the lower part of the south wall. A pair of legs belonging to **Skeleton 2005** (**Figure 11, Plate 14**) were preserved on the floor of **2004**. In addition, the end of a femur and the articulated hand of an additional individual, **Skeleton 2006** (also **Figure 11, Plate 14**), were seen protruding from the section of the trench within the area of tomb **2004**. This area was noted to be rich in disarticulated charnel bone, which was analysed as part of deposit **2003**.

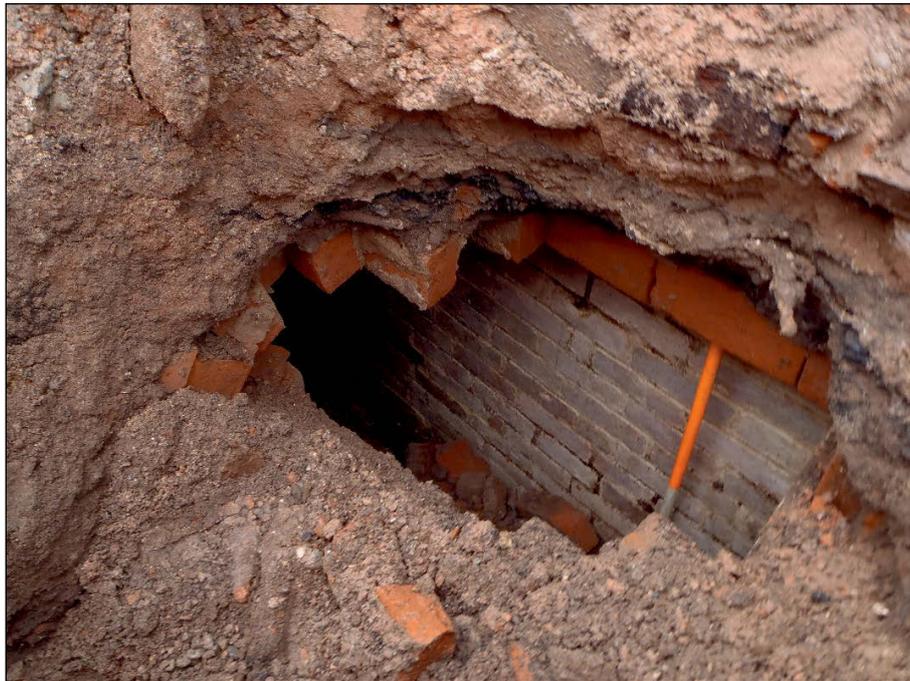
Plate 2: Vault 1022

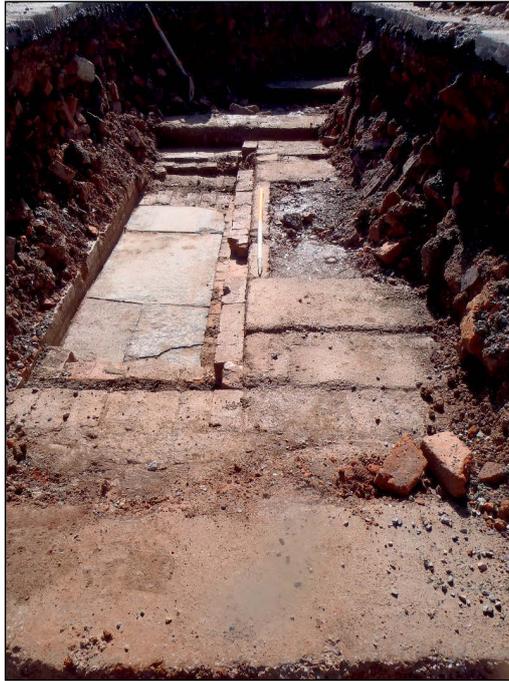
Plate 3: Structure 1014

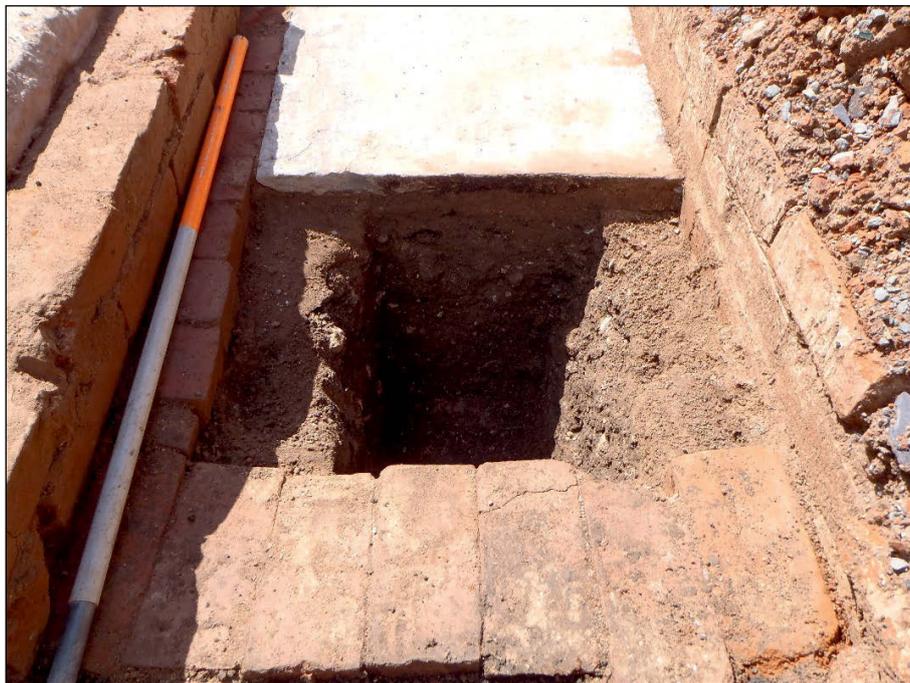
Plate 4: Made ground 1023 under structure 1014

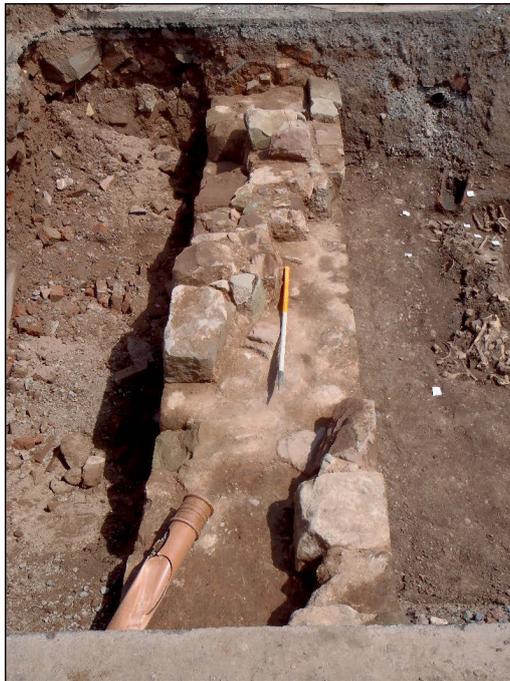
Plate 6: Church wall 2007

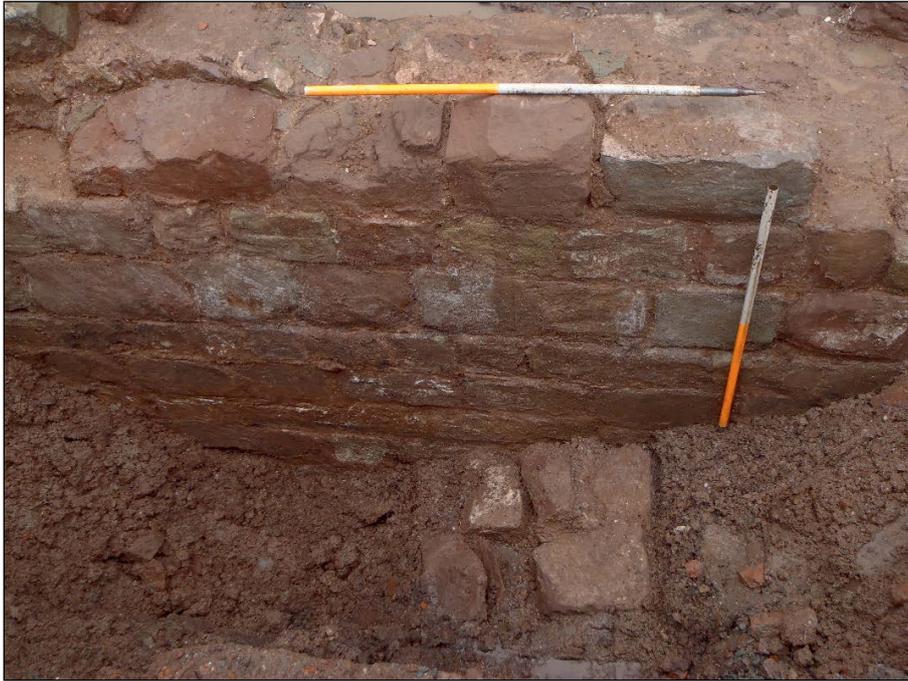
Plate 7: Structure **2008** abutting church wall

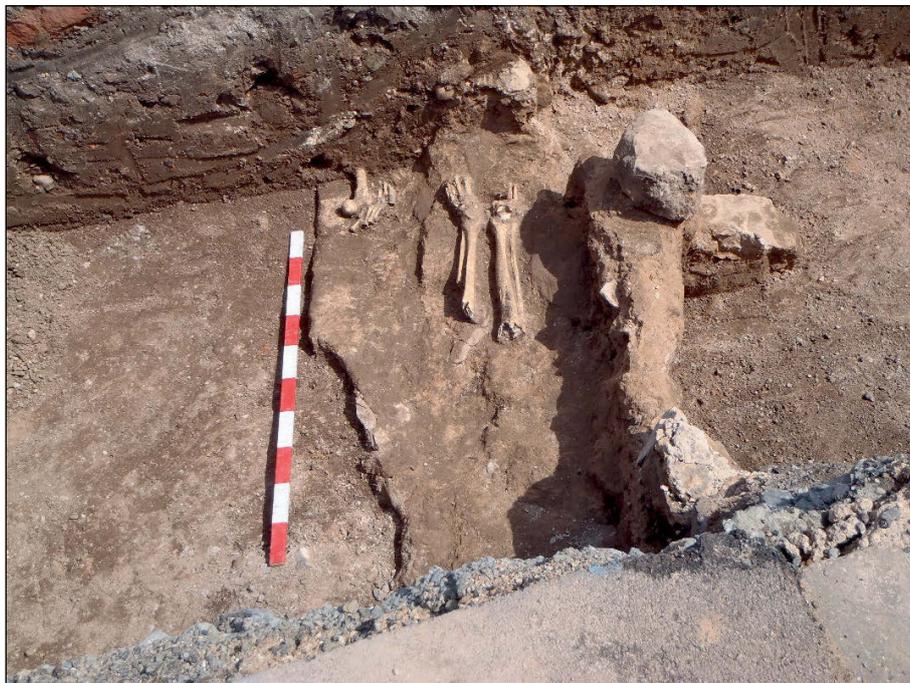
Plate 14: Vault **2004** and **Skeletons 2005** and **2006**

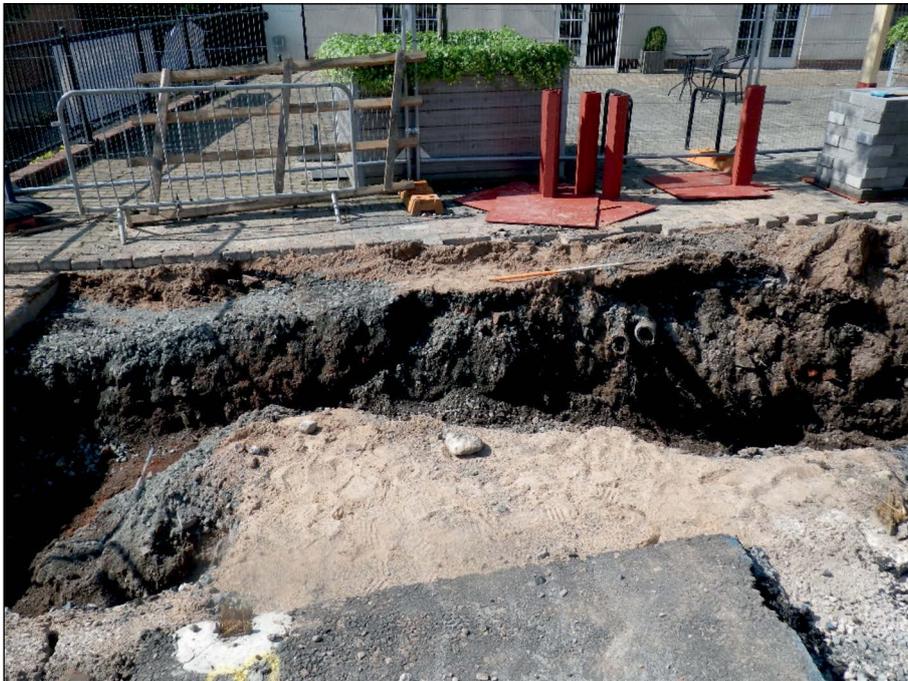
Plate 20: General shot of **trial pit 9**

Trial pit 9 (TP9) was orientated east to west and cut through **Trench 3** from the Worcestershire Archaeology evaluation. **TP9** was 8m by 3.2m and was excavated to a depth of 1.65m (bgs) (**Plate 20**). **TP9** revealed a utility pipe and the mains electricity cable from **TP7**. **TP9** identified layers of made ground that were found in **TP7** and **TP8**.
