# Severn Street, Worcester, Worcestershire

Archaeological Watching Brief Report

Ref: 104661.01  
March 2015

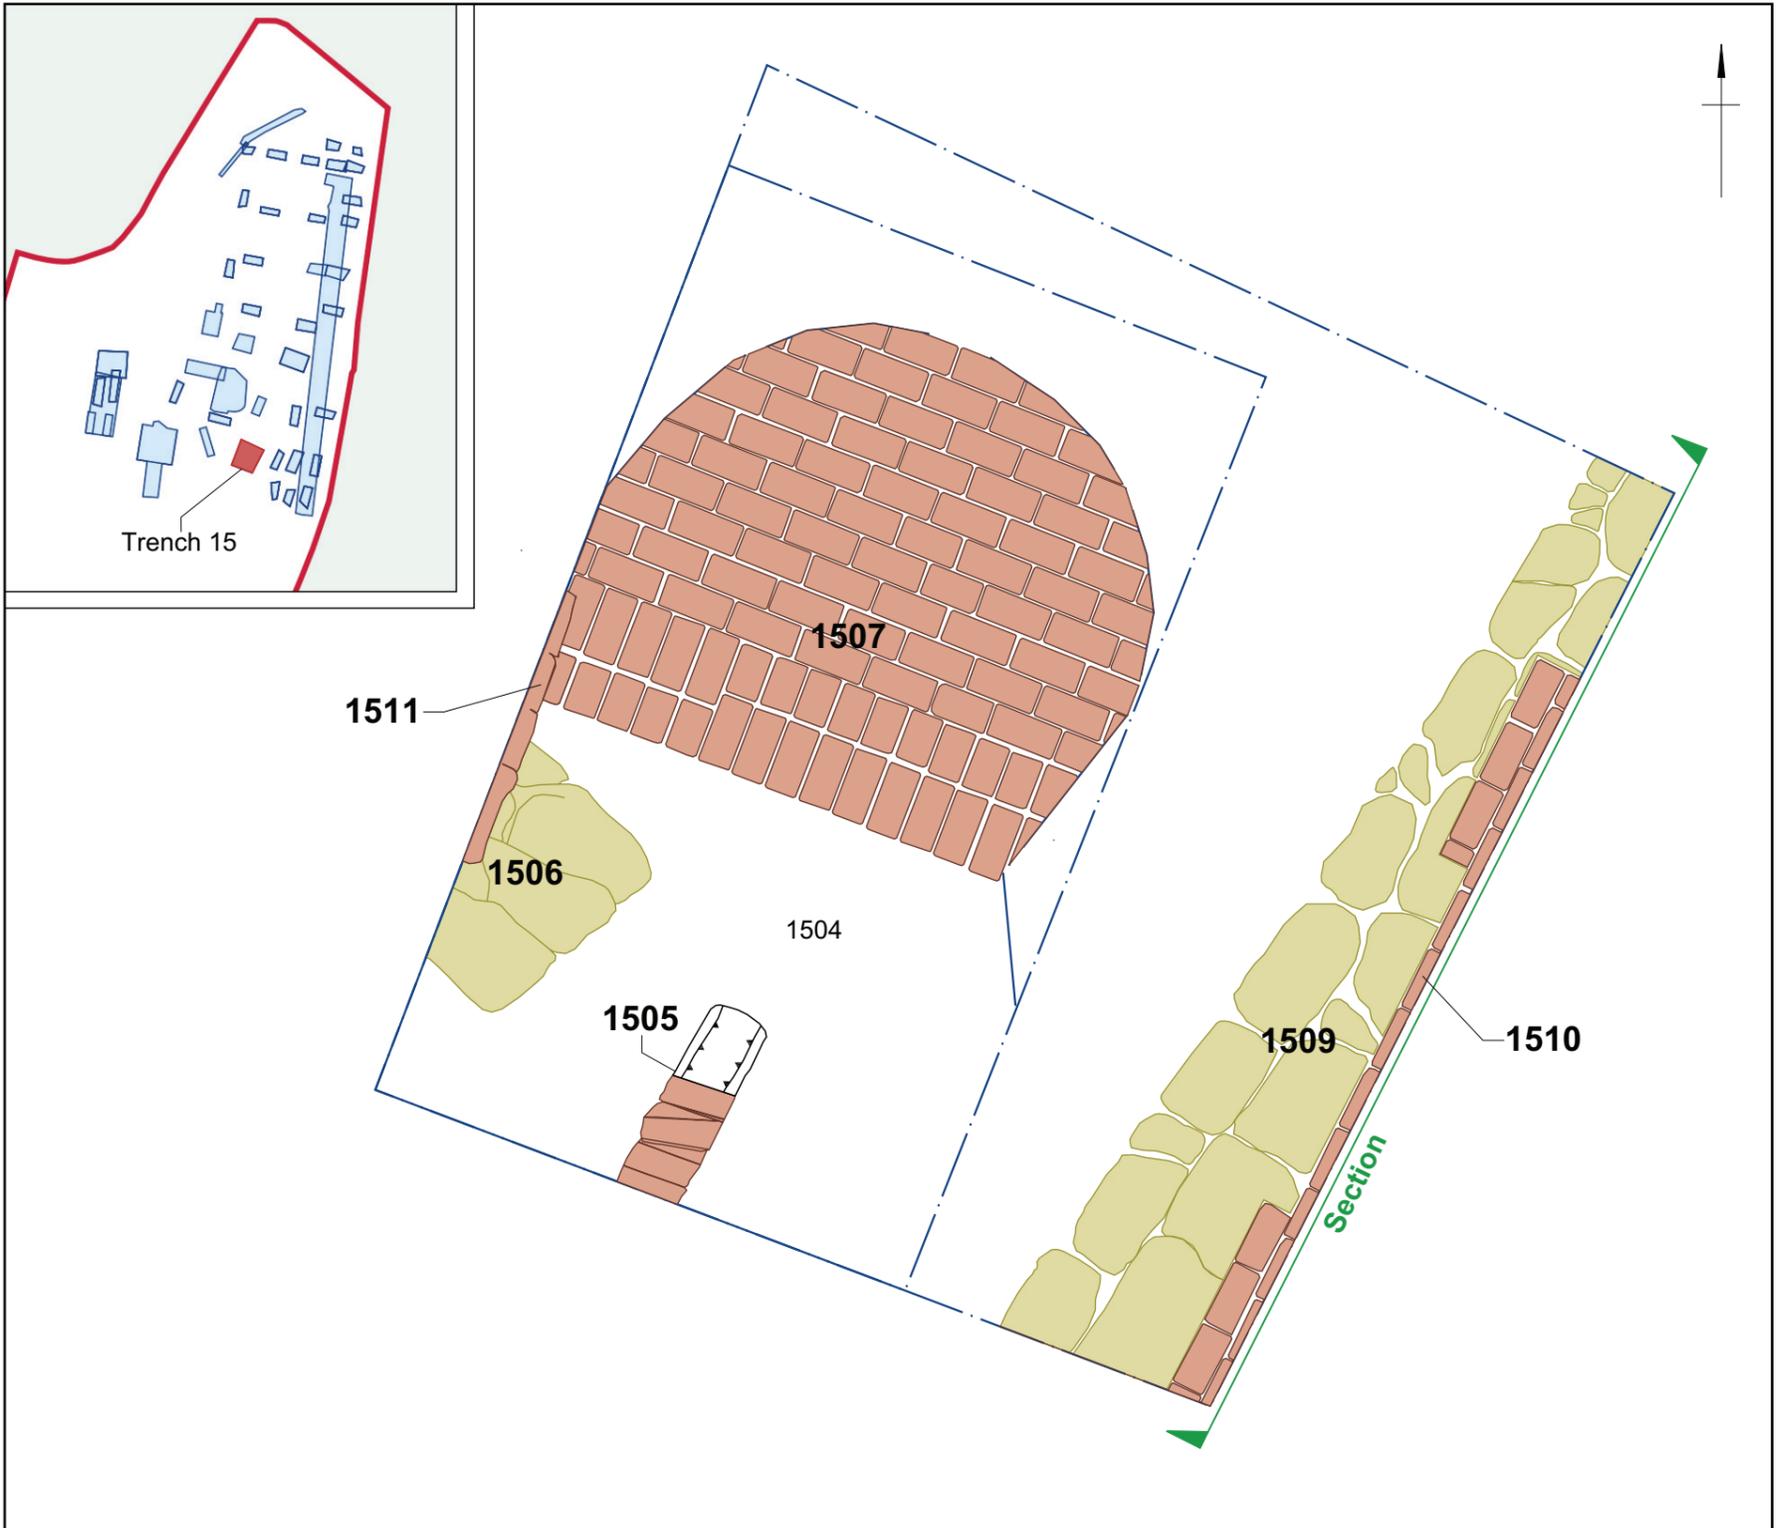
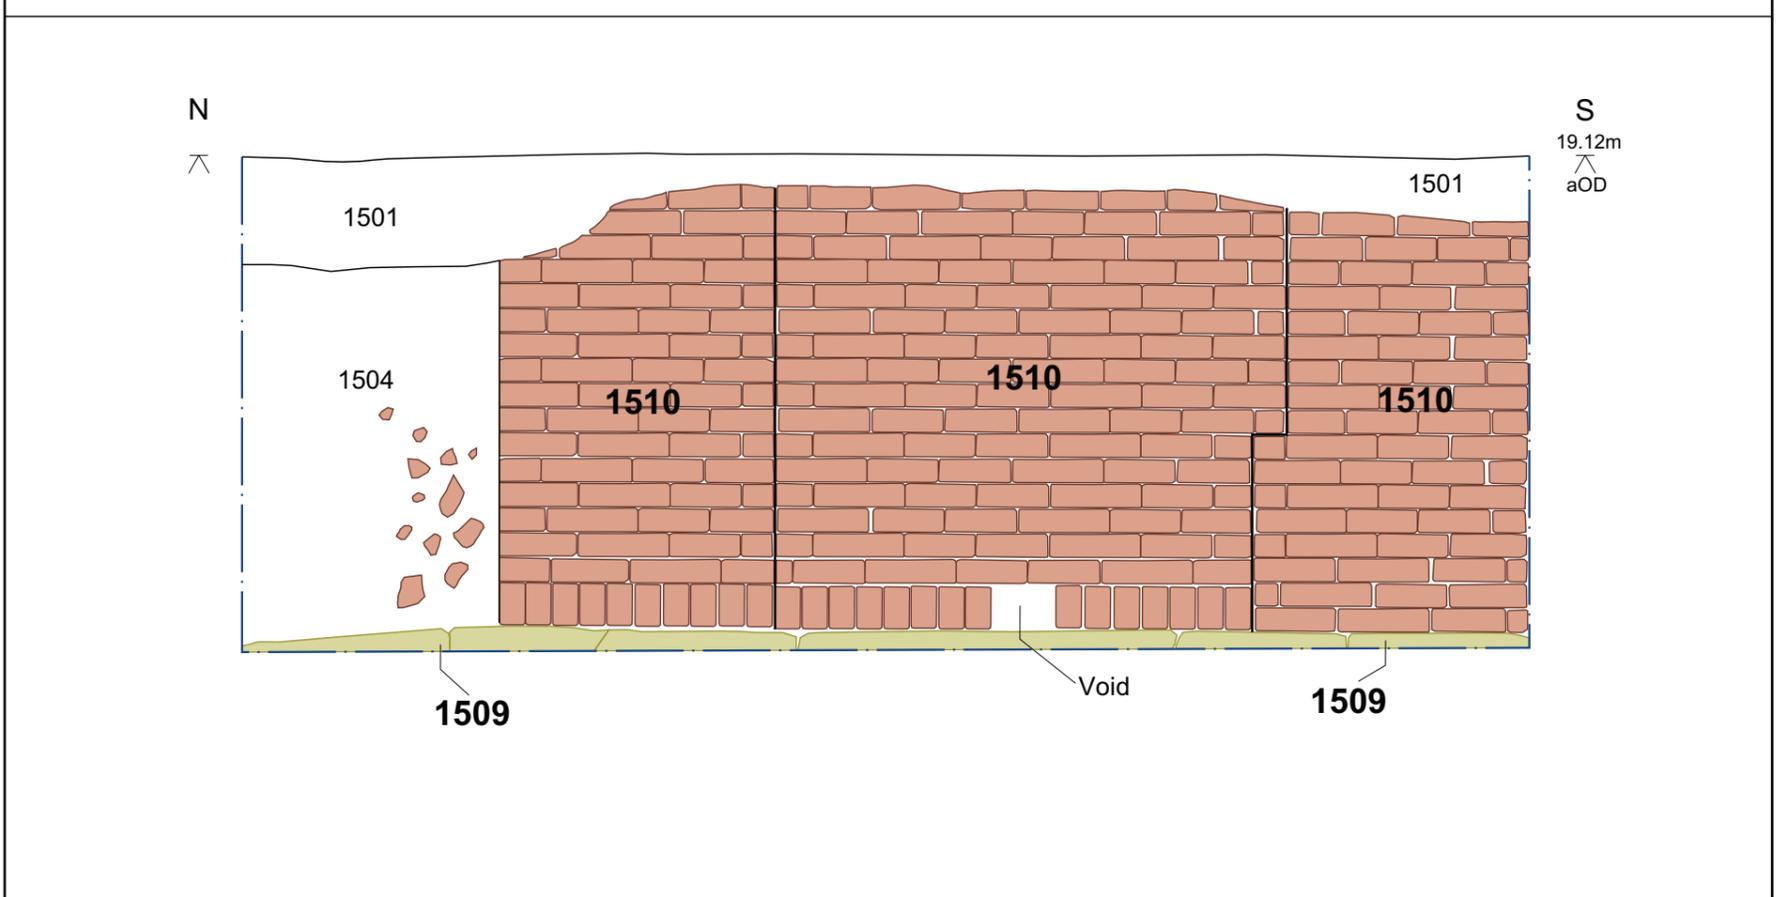
Figure 4

Plan of and section of **Trench 15**, medieval city wall **1509** and church buttress **1506**

- 4.3.3 The sandstone city wall (**1509**) was uncovered at 1.4m bgl (17.62m aOD) along the eastern edge of the trench (**Figure 4, Plate 3**). The distance between the medieval buttress and the medieval city wall in this area measured 0.7m to 0.8m. Due to the confined working area and to avoid damage to the medieval buttress only the top of the city wall was exposed to confirm its alignment and construction. The red sandstone wall was bonded with light pinkish white lime mortar with coarse white sand inclusions. The medieval city wall was linear with no signs of a corner, a tower or a change of alignment. At the northern end of the trench the sandstone city wall had a red brick addition (**1510**) replacing its upper courses.

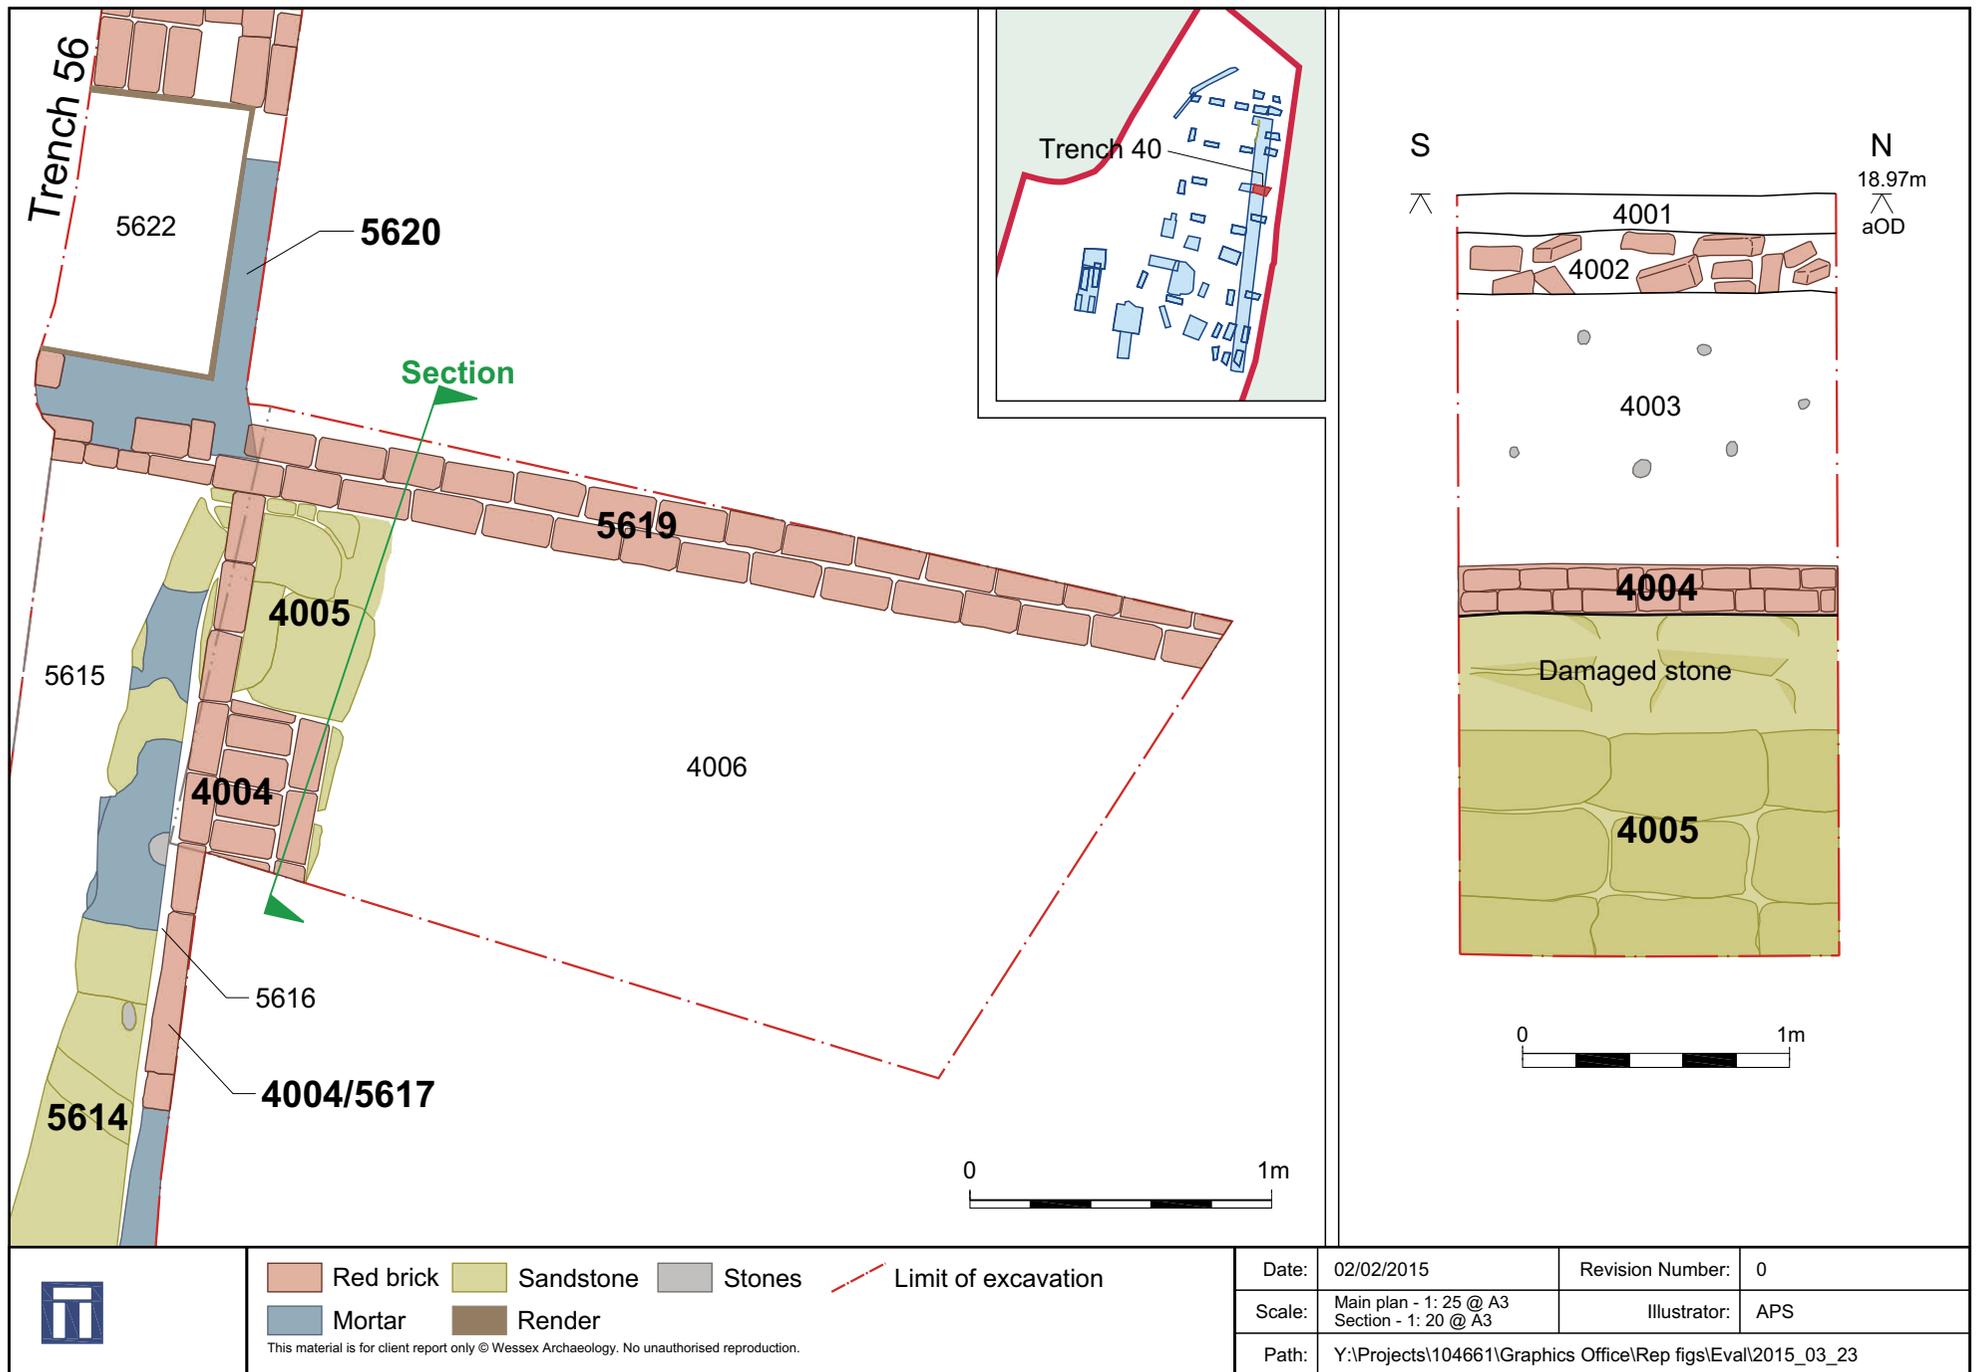
Figure 5

Plan of and section of **Trench 40**, medieval city wall **4005**

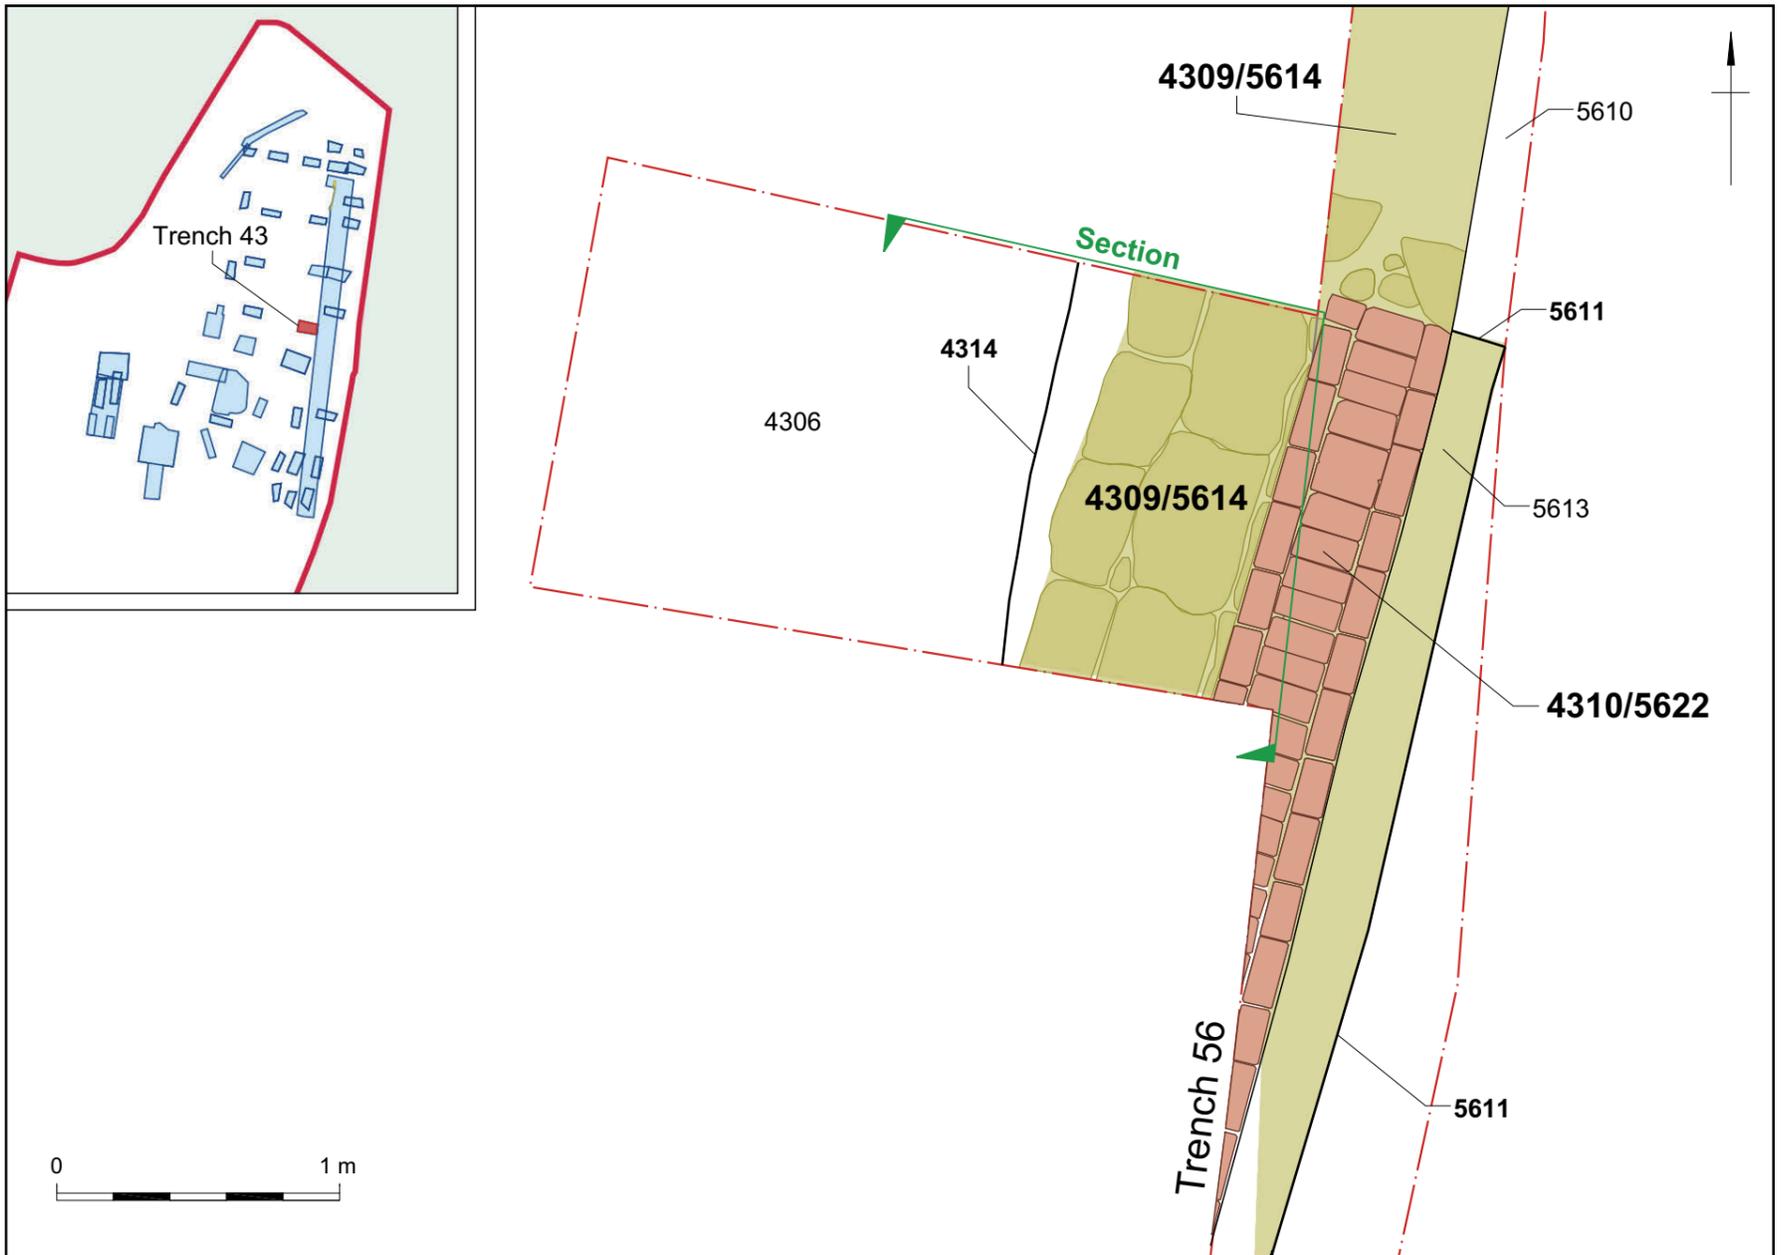
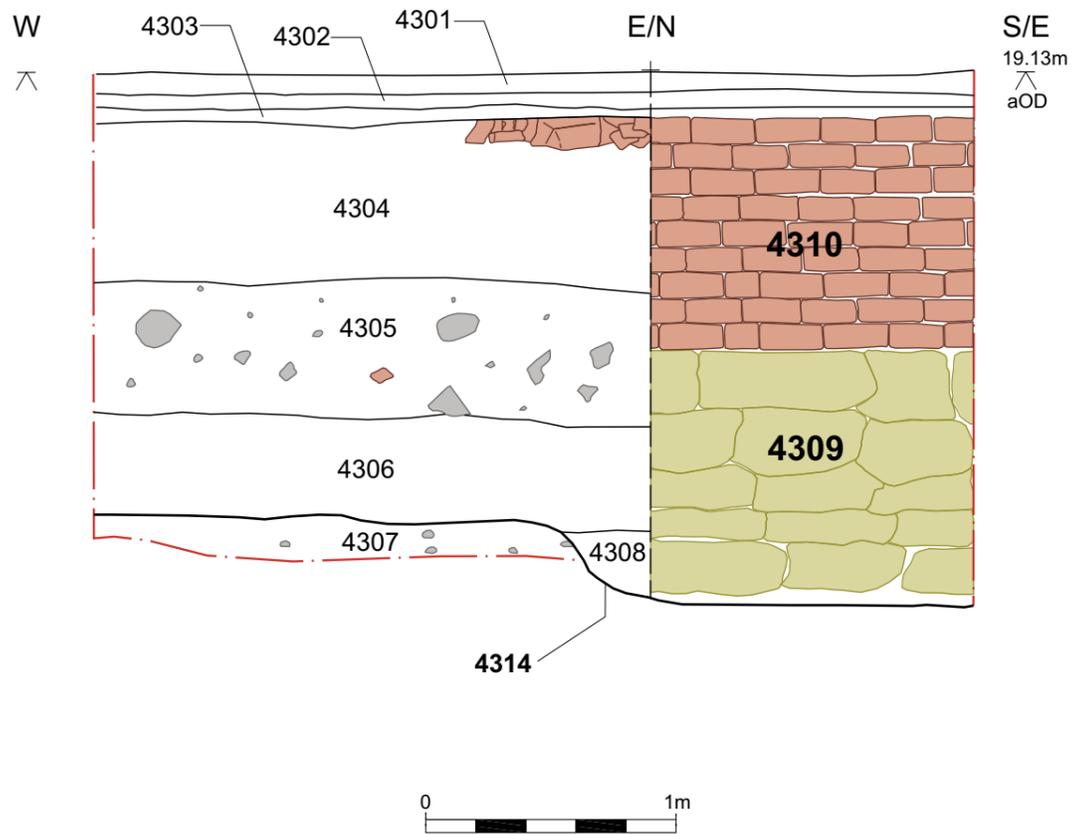
Figure 6

Plan of and section of Trench 43, medieval city wall 4309

- 4.3.5 **Trench 43** identified the sandstone medieval city wall at a depth of 1.1m bgl (18.03m aOD) (**Figure 6, Plate 5**), with the upper courses destroyed during the construction of the car park and levelled with a layer of dark brown silty sand containing abundant charcoal and ash (**4303**). The construction of medieval city wall **4309** was identical to that recorded in **Trench 40**. The sandstone foundations (**4311**) of the Victorian church abutted the medieval sandstone wall at the southern section of the trench.

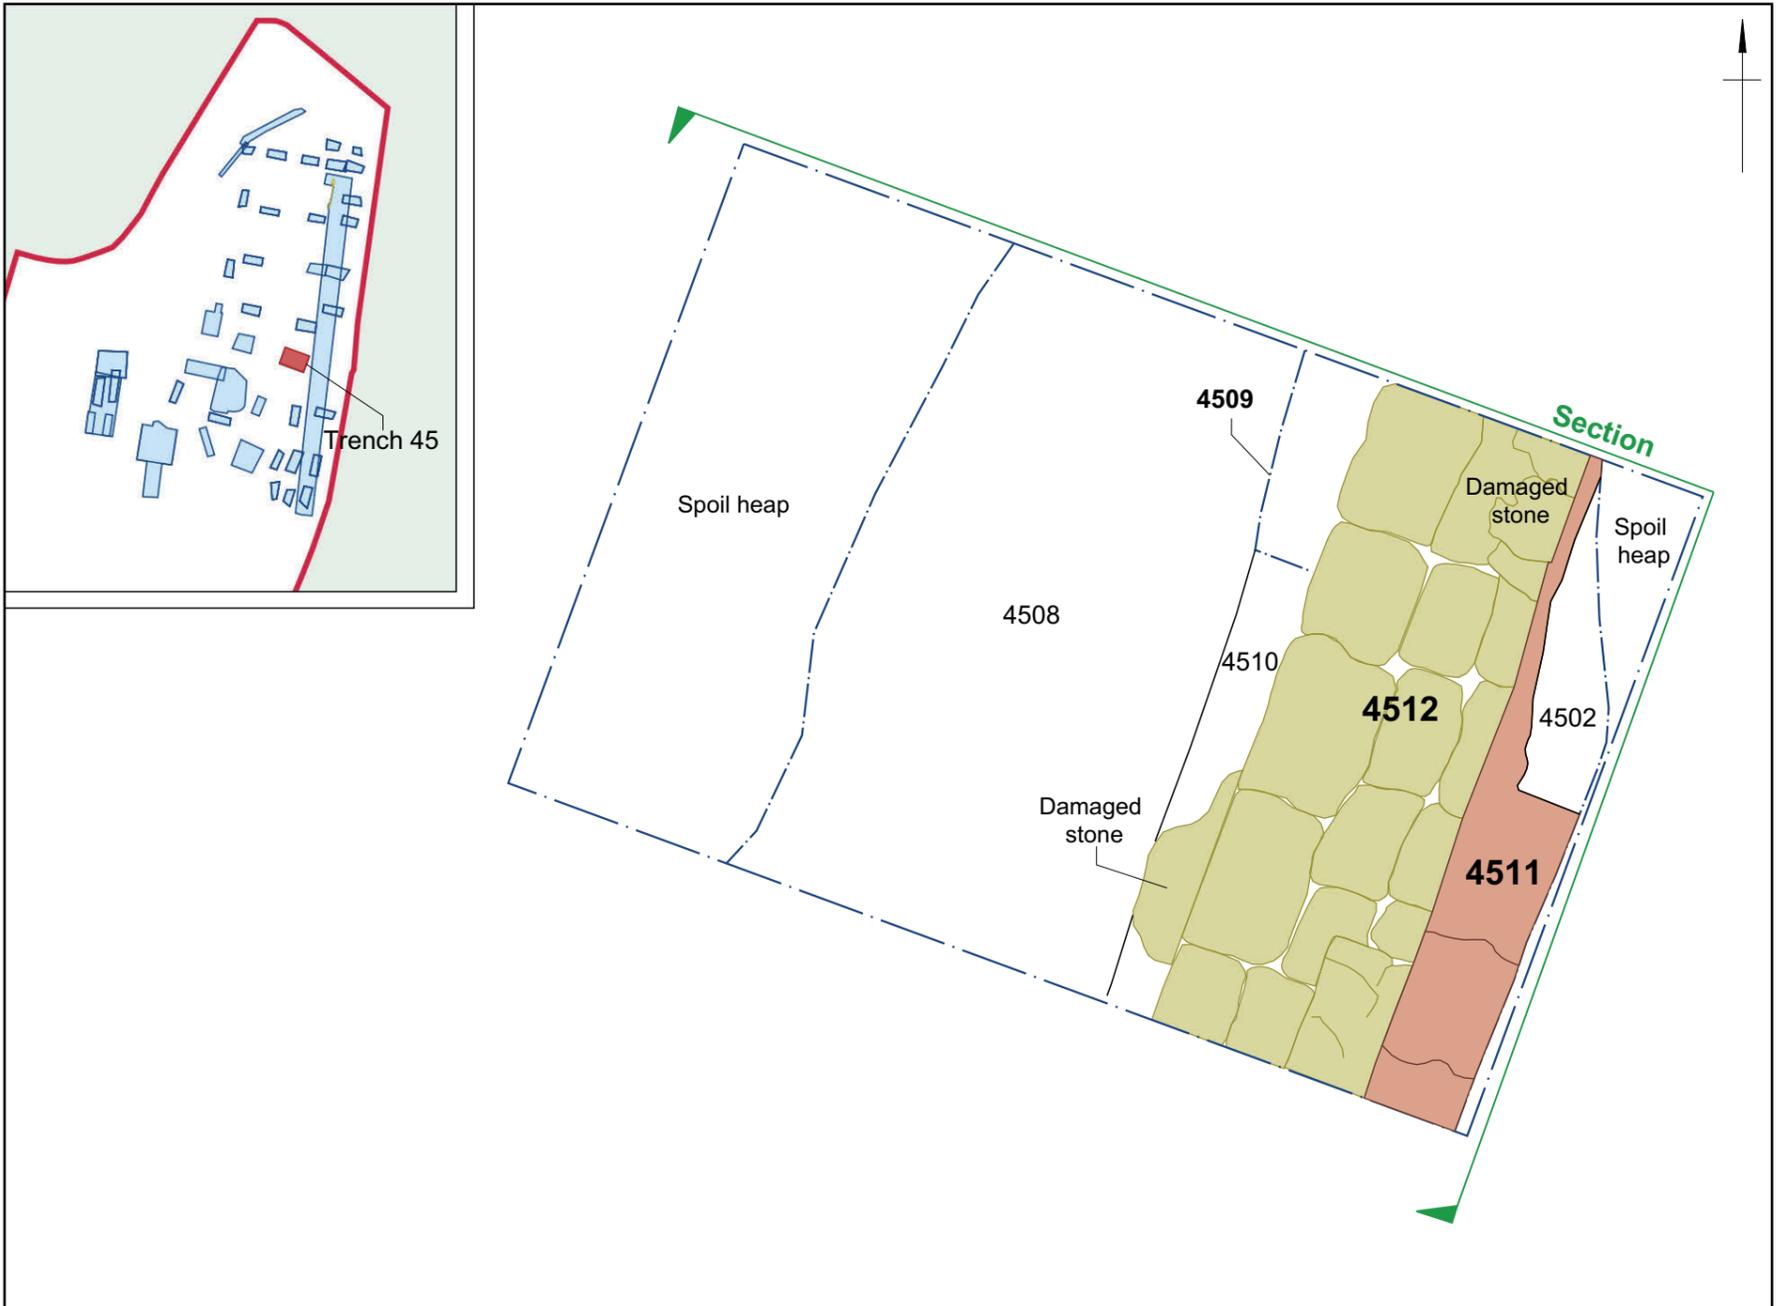
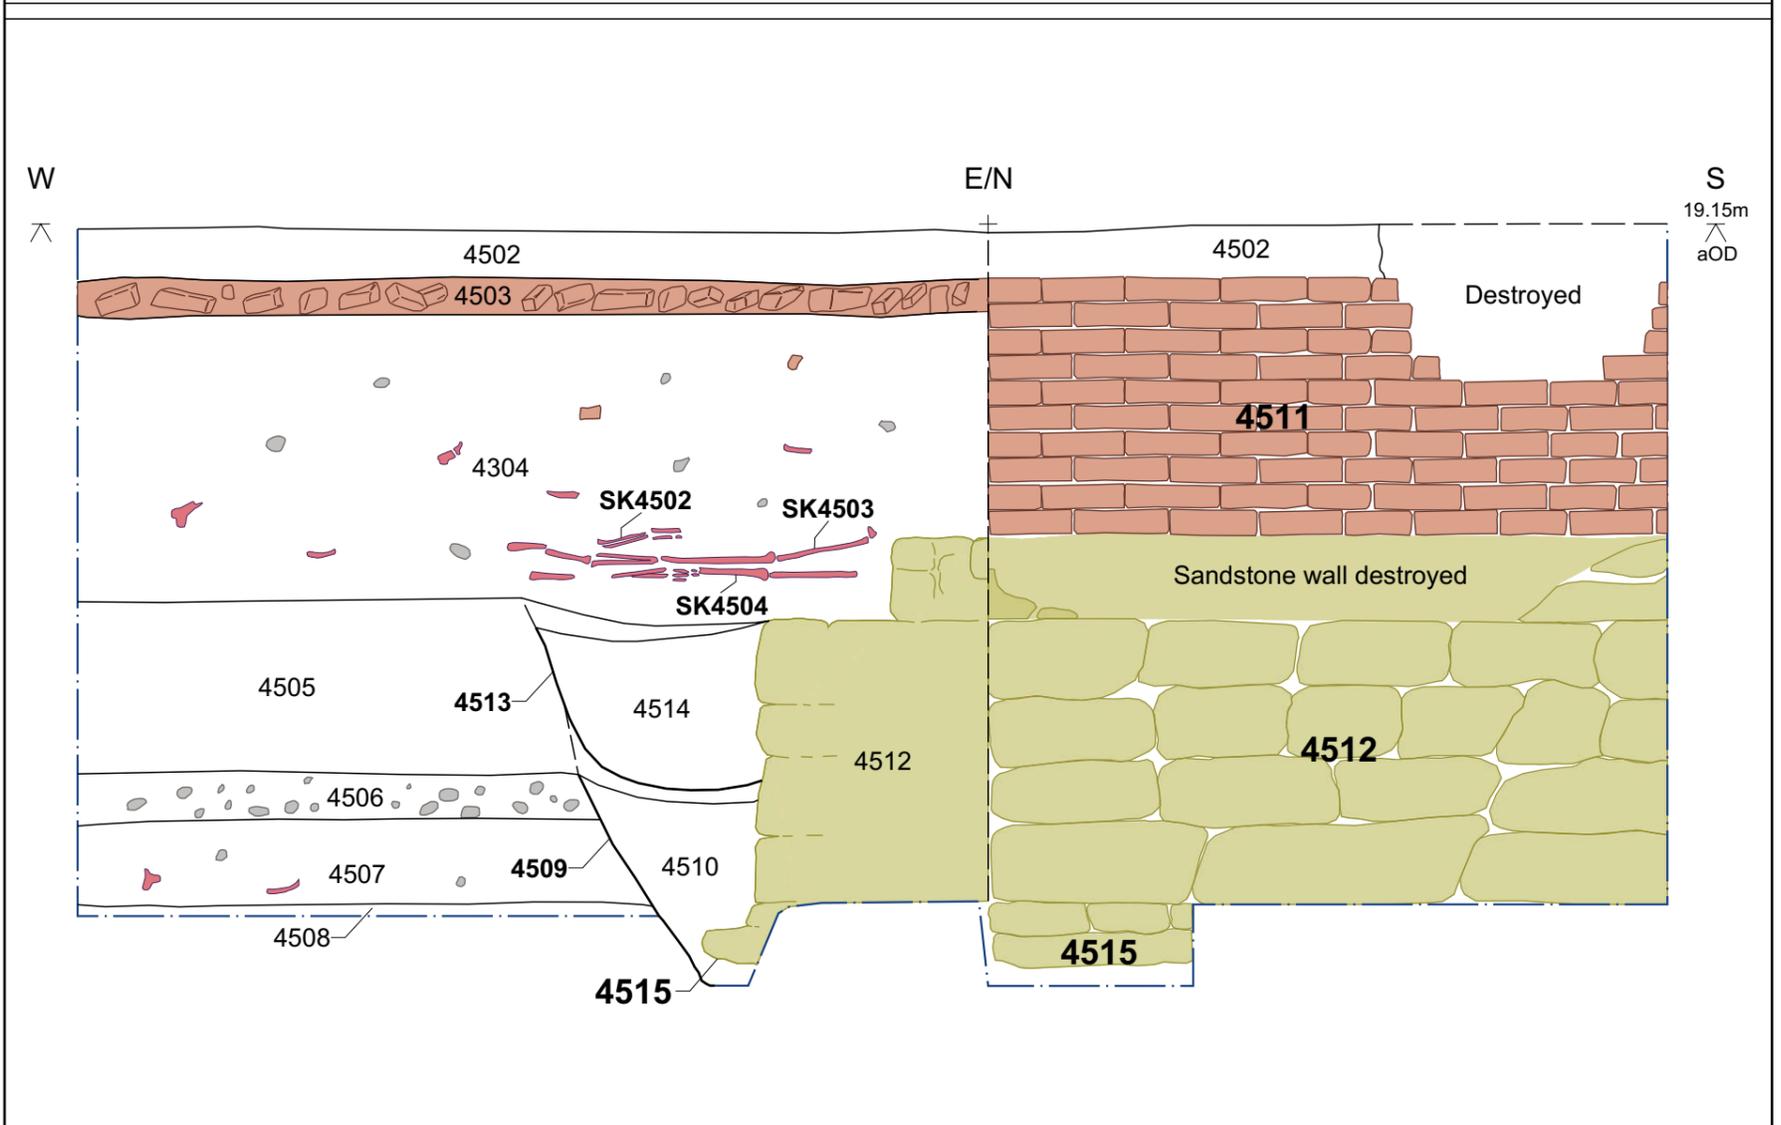
Figure 7

Plan and section of Trench 45, medieval city wall 4512

- 4.3.9 The primary construction cut (**4509**) for the foundation was filled with mortar layer **4515** upon which the city wall was constructed. The construction cut was then backfilled with brown silty sand **4510** which contained a small piece of heavily abraded Roman pottery at its base. The construction cut truncated natural grey clay **4508** which was recorded at a maximum depth of 2.8m bgl (16.35m aOD). A secondary construction cut was also recorded (**4513**) along with a secondary phase of backfilling (**4514**). The upper level of recut **4513** is at the same level as the stepping in of the city wall which indicates that this steeping-in related to a second phase of construction/repair to the original city wall structure.

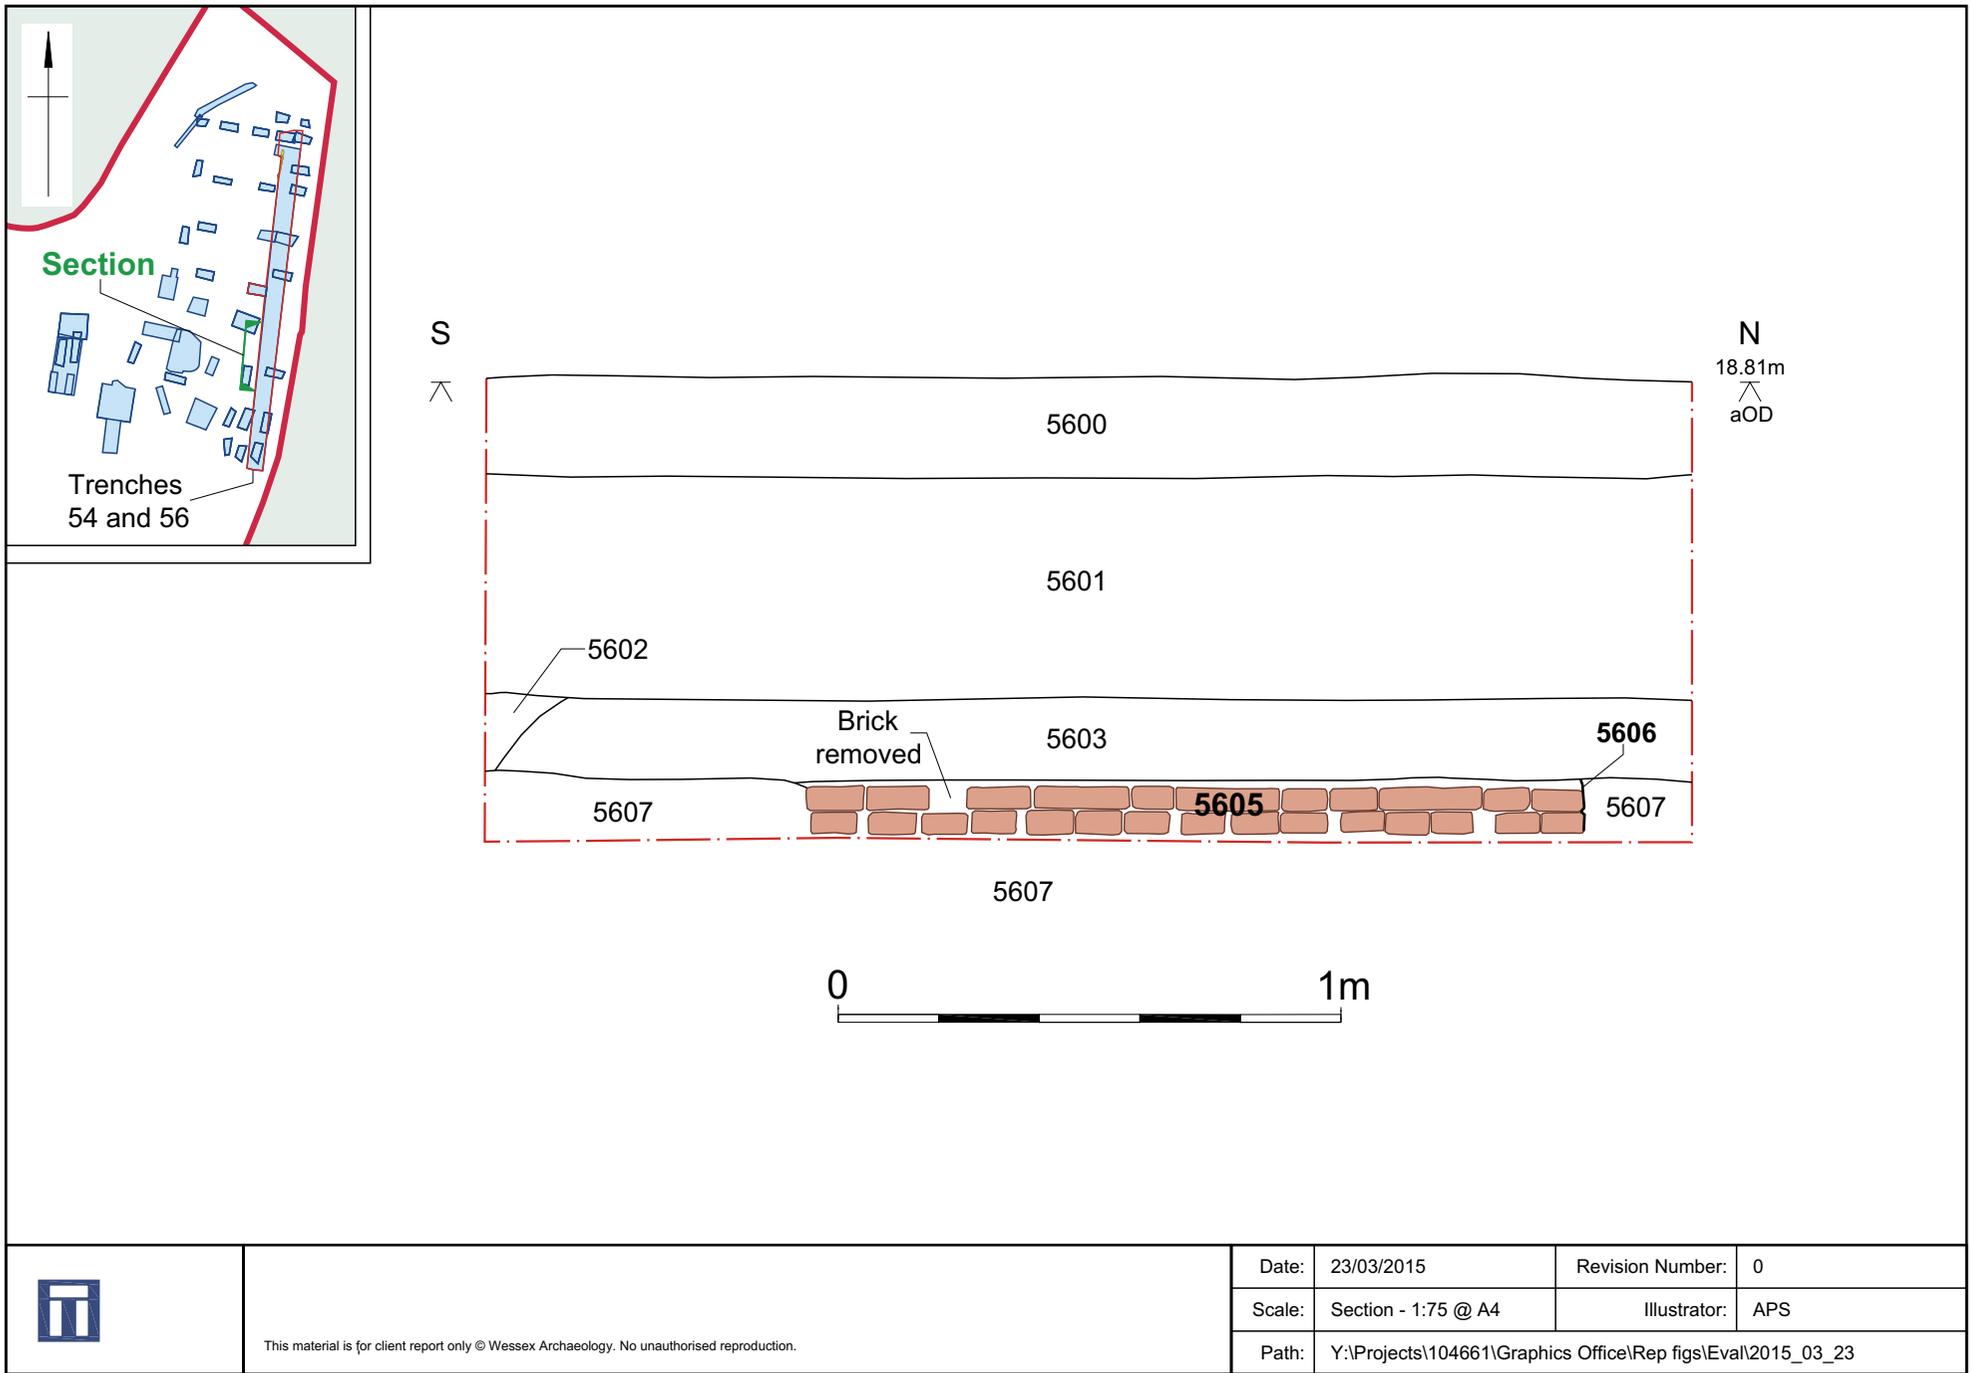
Figure 9

Section of Trench 56, red brick surfaces 5605 and 5606

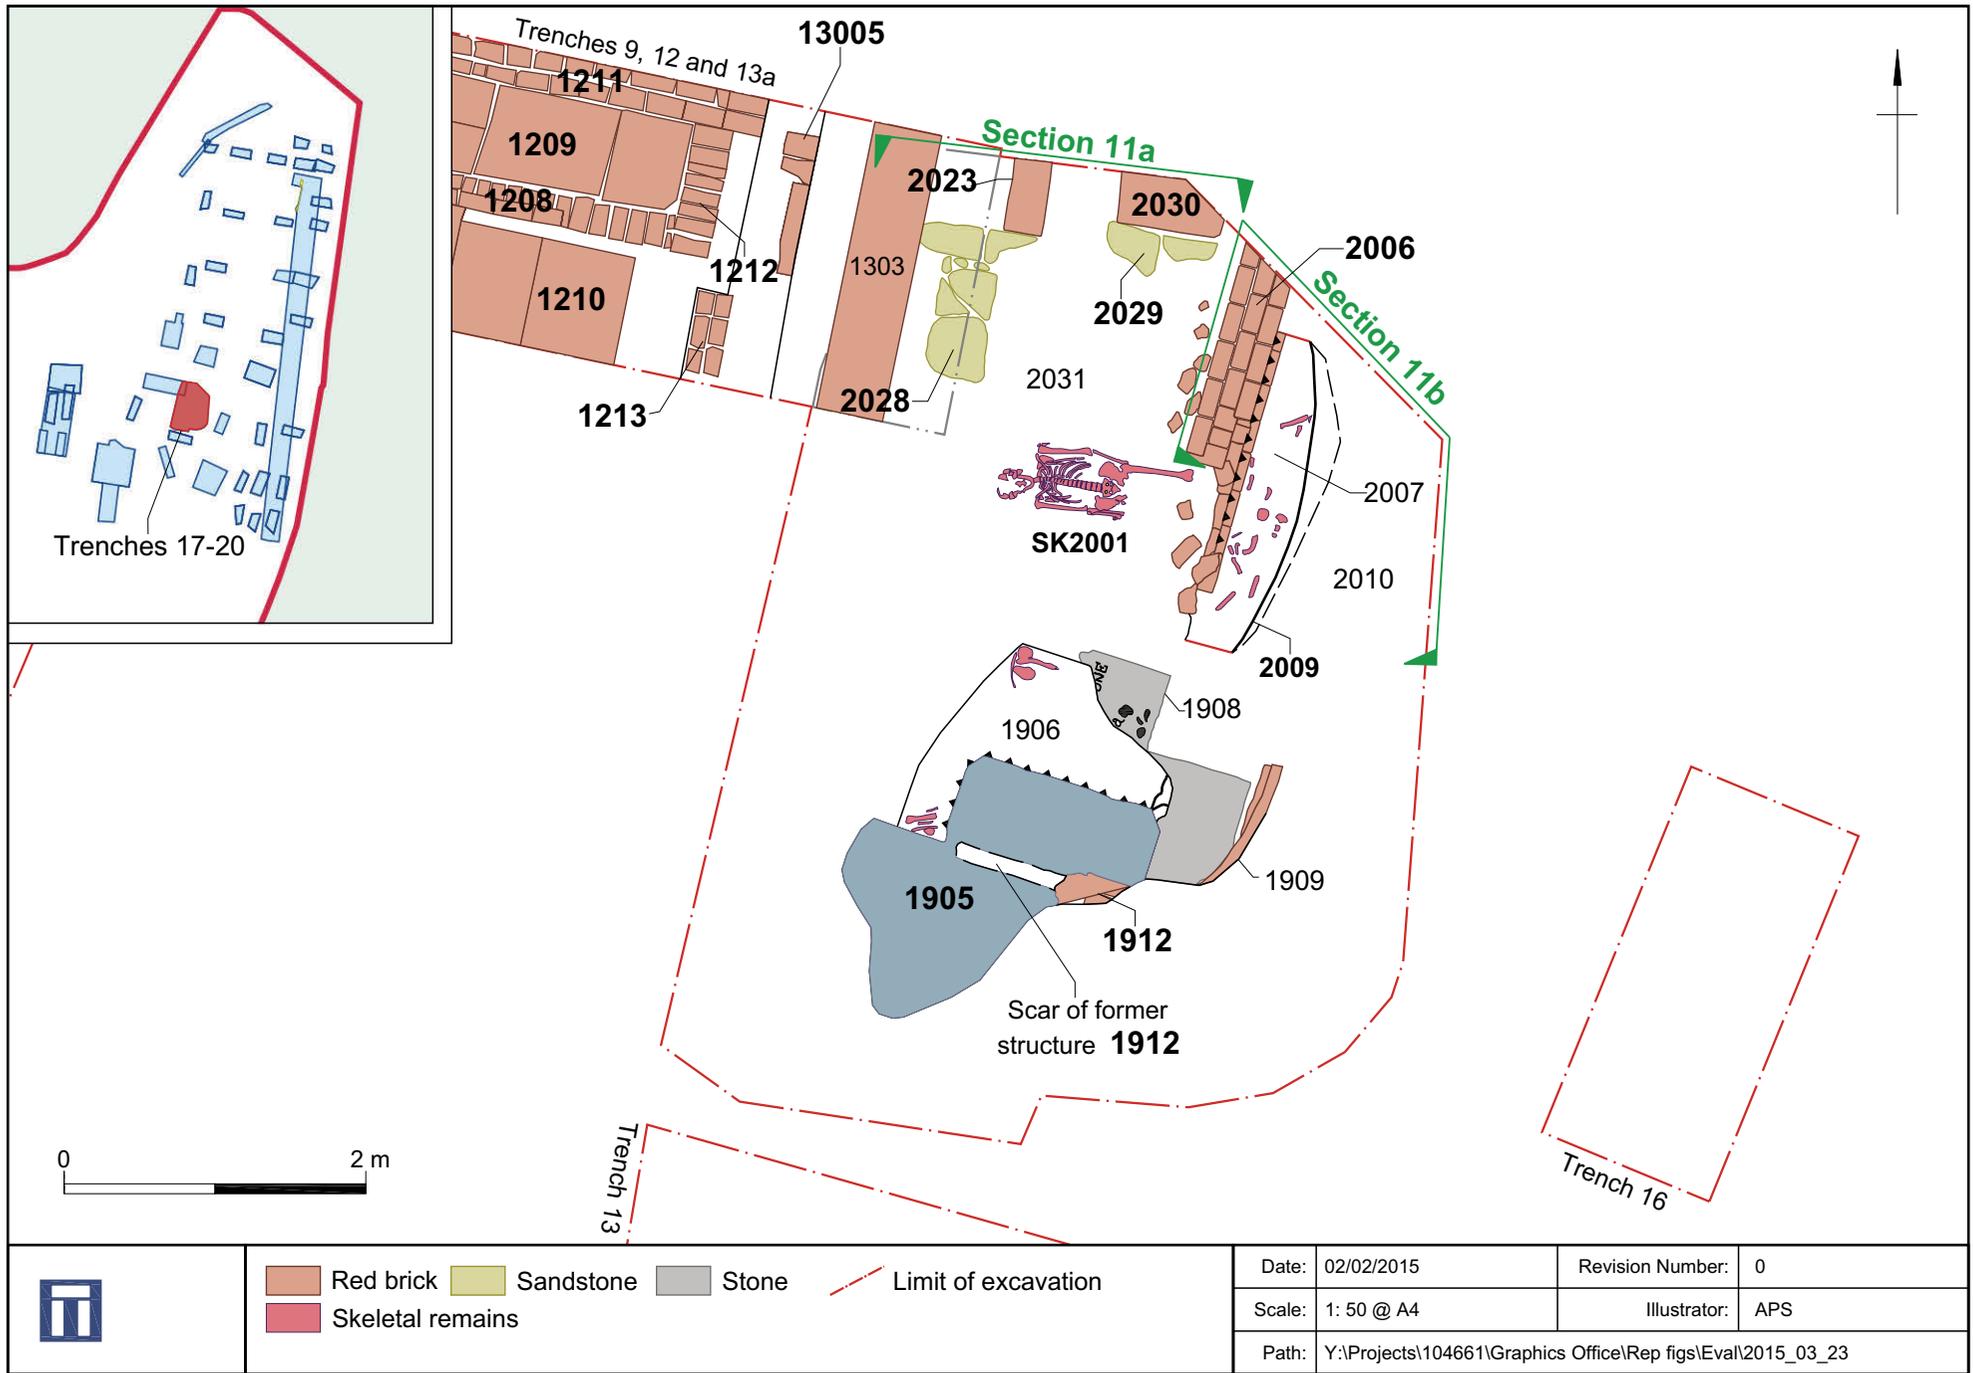
Figure 10

Plan of Trenches 17-20

- of the vaults consisted of a brown silty sand (2011) with disarticulated human remains recorded.
- 4.5.21 The eastern wall of the Victorian church (2020/2021) was recorded at the eastern edge of the excavation area (Figure 10). Sandstone foundation 2020 was identical in form to wall 1606 described in Section 4.5.16. A parallel red brick wall (2006) was recorded 1.4m to the west of wall 2020. Wall 2006 was north-south aligned, 0.4m in width and survived to 1m above its foundations at 17.90m aOD. Wall 2006 represents an internal wall to the Victorian church.
