# Severn Street, Worcester, Worcestershire

Archaeological Watching Brief Report

Ref: 104661.01  
March 2015

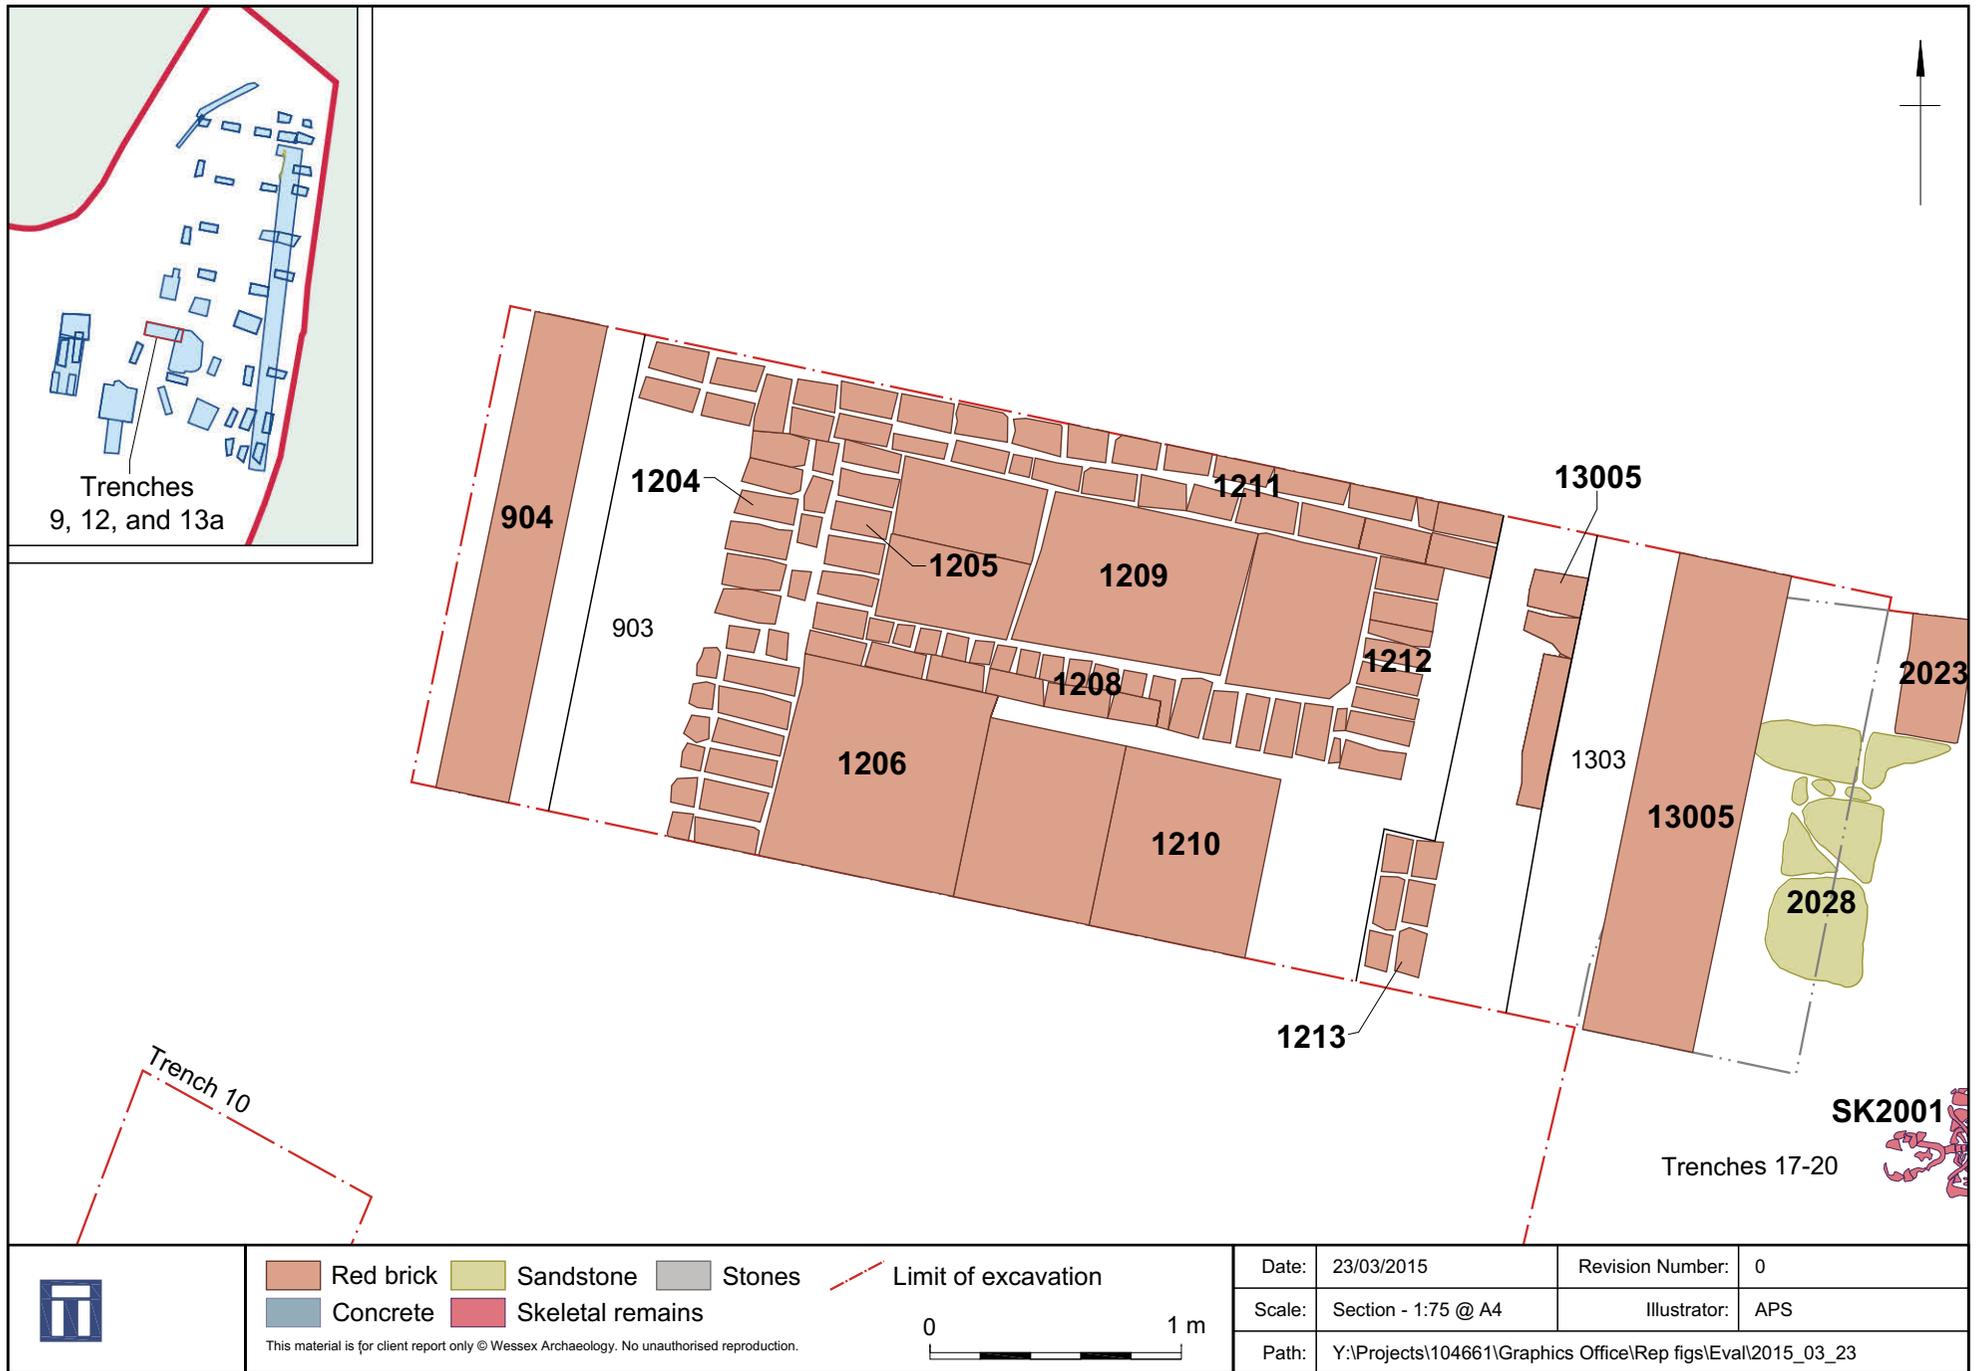
Figure 13

Plan of Trench 9, 12 and 13a

Immediately to the south of concrete beam **904**, red brick structure **1204** was recorded. This north-south aligned wall formed an extension to a brick burial shaft defined by **1205**, **1208**, **1209**, **1212** and **1211** (**Figure 13**, **Plate 12**). Structure **1204** was three skins thick and constructed from the same bricks as found in the adjacent vault. Ledger stone **1209** (**Appendix 2**, **Gravestone no. 15**, **16**) was lifted and the shaft grave investigated. The fill (**1214**) was heavily disturbed and contained disarticulated human remains. The human bones were recovered for reburial. Grave fill **1214** contained animal bones, a clay pipe piece, glass and post-medieval pottery in addition to the disturbed human remains.

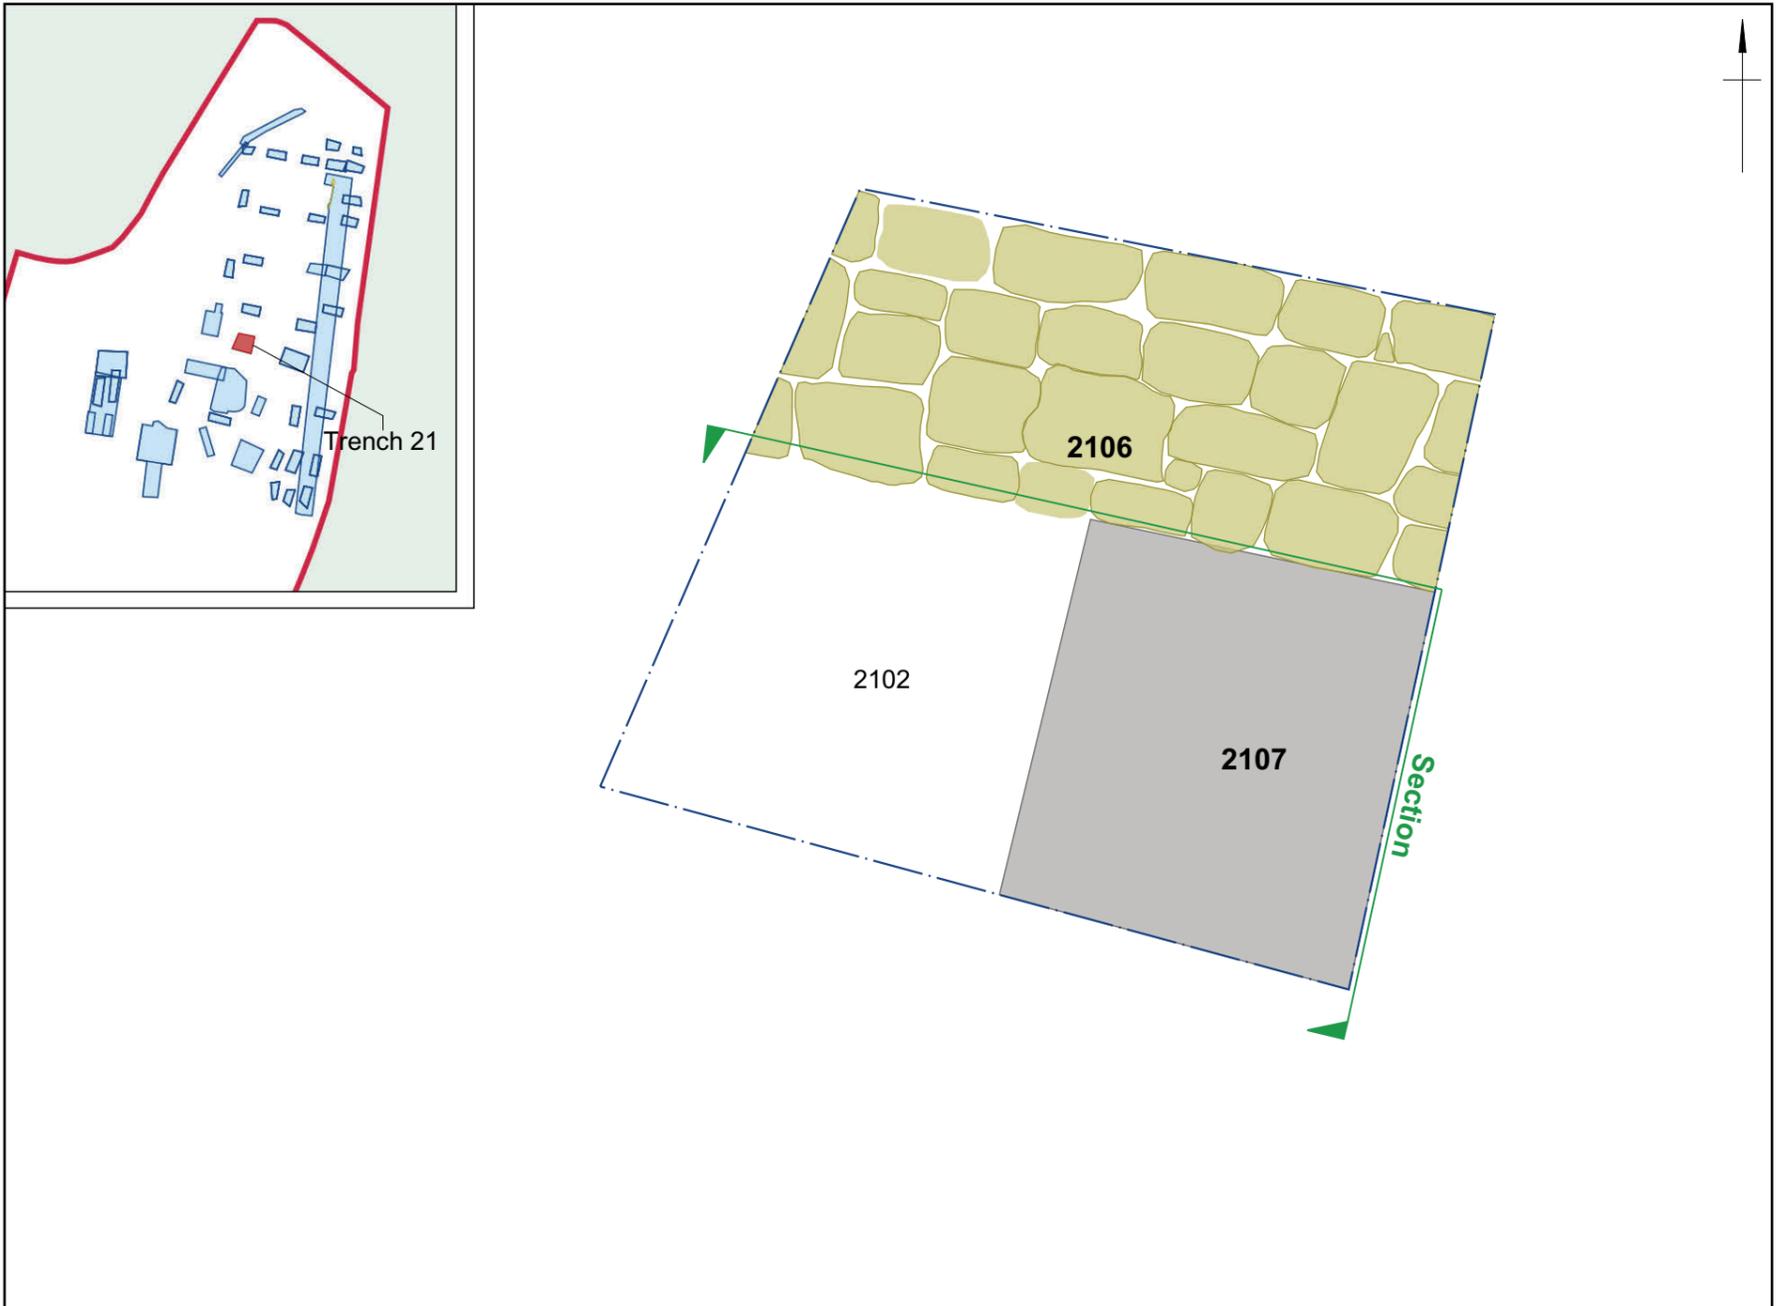
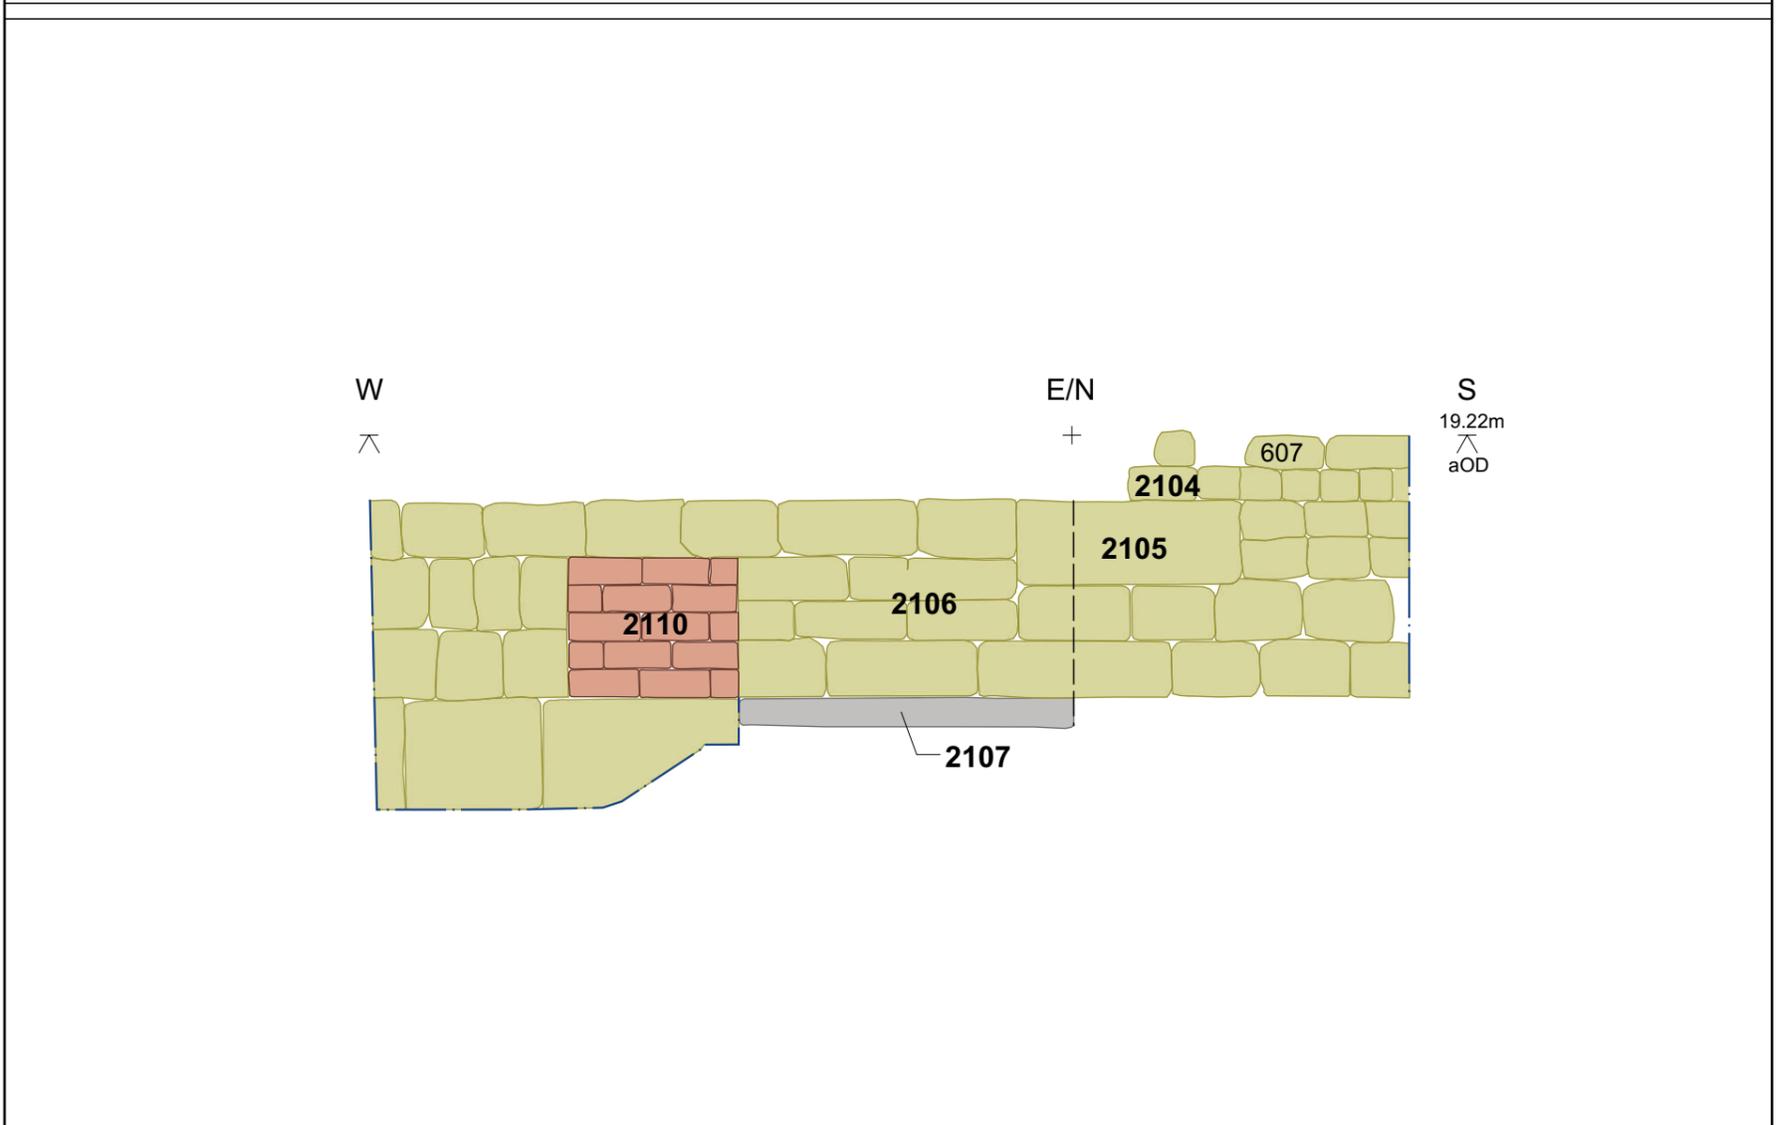
Figure 16

Plan and section of **Trench 21**

- 4.5.25 Trench 21 was flanked on the northern and eastern side by sandstone foundation walls similar in construction and fabric to other walls of the Victorian church across the Site (Figure 16). On both sandstone walls 2104 and 2105 the remnants of white paint was visible. The north-south aligned wall consisted of a red sandstone wall foundation (2105) which was excavated to a depth of 1.75m bgl (17.47m aOD). On top of this sandstone foundation was a superstructure of two courses of red brick (2104), which was bonded with a yellow mortar. The east-west aligned sandstone wall foundation (2106) was of similar depth and a width to 2104. A rectangular opening in this wall (2110) had been blocked in the lower part with a lintel (2111) and a red brick structure (2112) was built into the upper part of this opening (Figure 16, Plate 19). At a depth of 1.75m bgl a ledger stone associated with the Chamberlain family was recovered (Gravestone no. 1, Appendix 2, Plate 22). This ledgerstone and surrounding structures represents the possible entrance to a crypt associated with the Chamberlain family. No evidence for a grave was found beneath the *in situ* ledgerstone, indicating the remains were housed elsewhere within the church and presumably removed for reburial during the demolition of the Victorian Church. The gravestone was removed for safe keeping and the associated walls left *in situ* as the piling point did not immediately affected the structure.

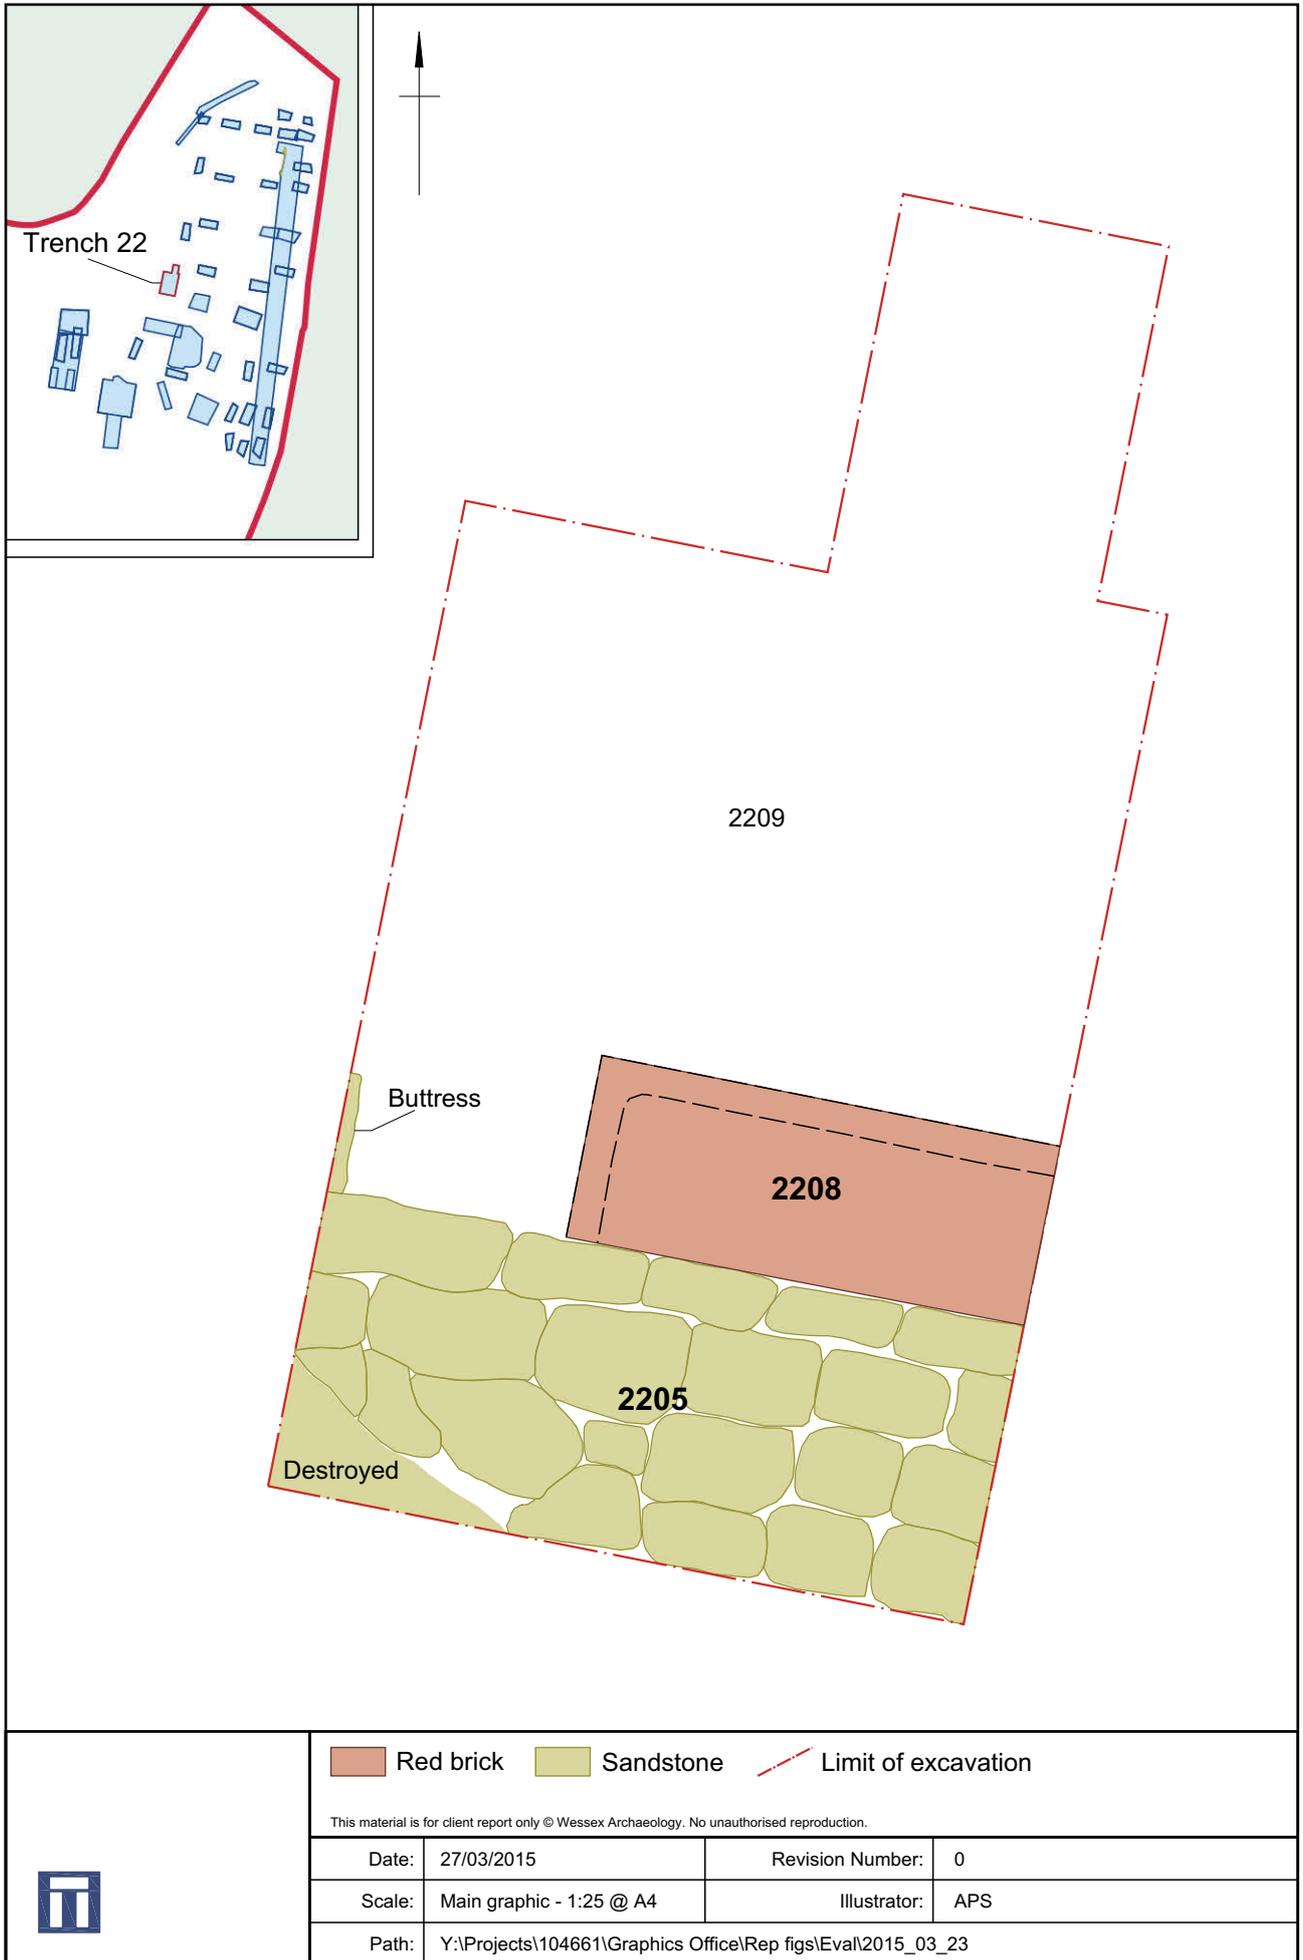
Figure 17

Plan of Trench 22

- 4.5.26 Trench 22 identified a sandstone foundation (2205) similar in structure and fabric to other parts of the Victorian Church wall foundation on Site (Figure 17). The wall formed the northern wall of the Victorian church, was 0.9m wide and extended to a depth of 2.2m bgl (17.05m aOD). To the north of the church wall a red brick vault (2208) had

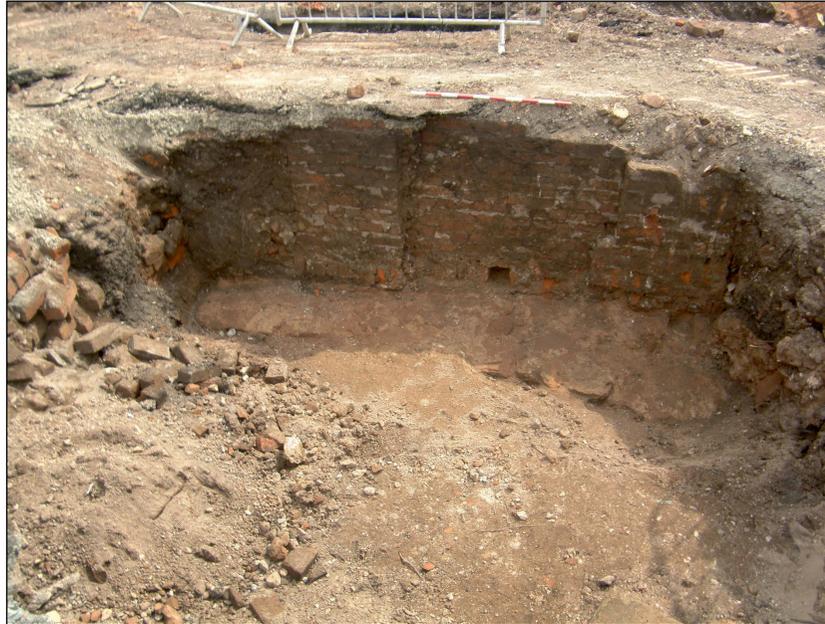
Plate 3: Medieval city wall within **Trench 15**, west facing section of **1509**

- 4.3.3 The sandstone city wall (**1509**) was uncovered at 1.4m bgl (17.62m aOD) along the eastern edge of the trench (**Figure 4, Plate 3**). The distance between the medieval buttress and the medieval city wall in this area measured 0.7m to 0.8m. Due to the confined working area and to avoid damage to the medieval buttress only the top of the city wall was exposed to confirm its alignment and construction. The red sandstone wall was bonded with light pinkish white lime mortar with coarse white sand inclusions. The medieval city wall was linear with no signs of a corner, a tower or a change of alignment. At the northern end of the trench the sandstone city wall had a red brick addition (**1510**) replacing its upper courses.

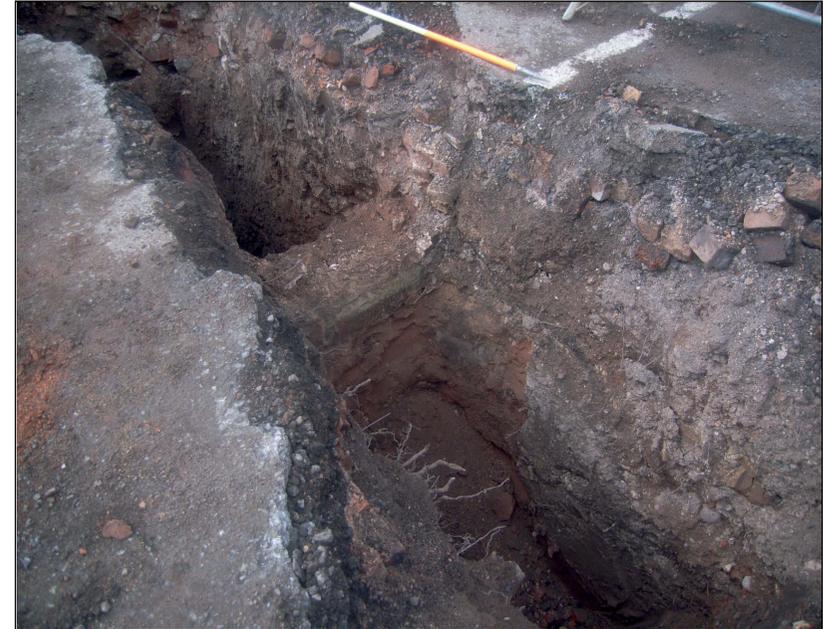
Plate 4: Medieval city wall **Trench 40**, east facing section of **4005**

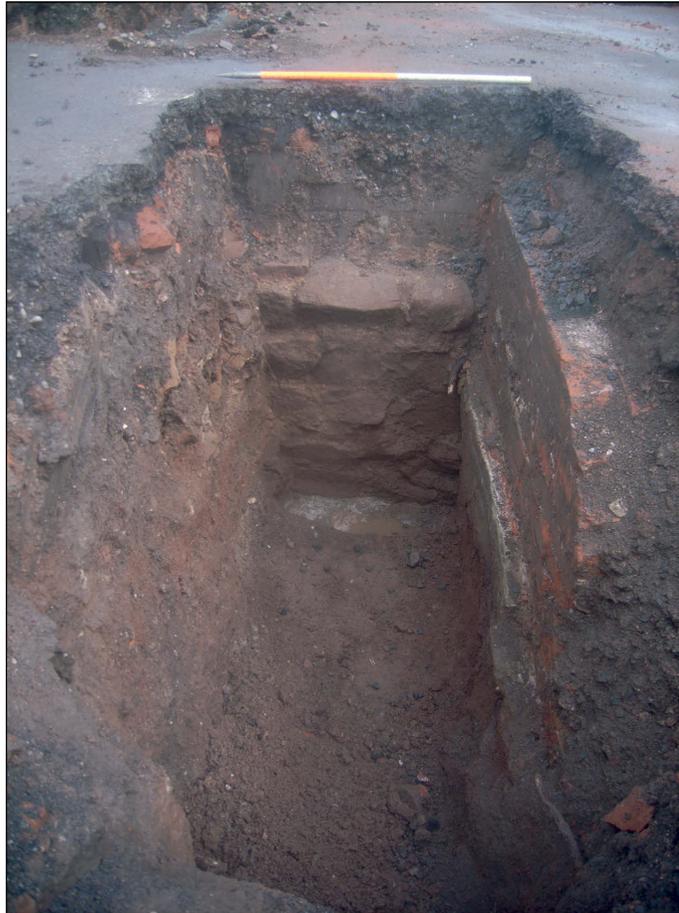
Plate 5: Medieval city wall **Trench 43**, west facing section of **4309**

- 4.3.5 **Trench 43** identified the sandstone medieval city wall at a depth of 1.1m bgl (18.03m aOD) (**Figure 6, Plate 5**), with the upper courses destroyed during the construction of the car park and levelled with a layer of dark brown silty sand containing abundant charcoal and ash (**4303**). The construction of medieval city wall **4309** was identical to that recorded in **Trench 40**. The sandstone foundations (**4311**) of the Victorian church abutted the medieval sandstone wall at the southern section of the trench.

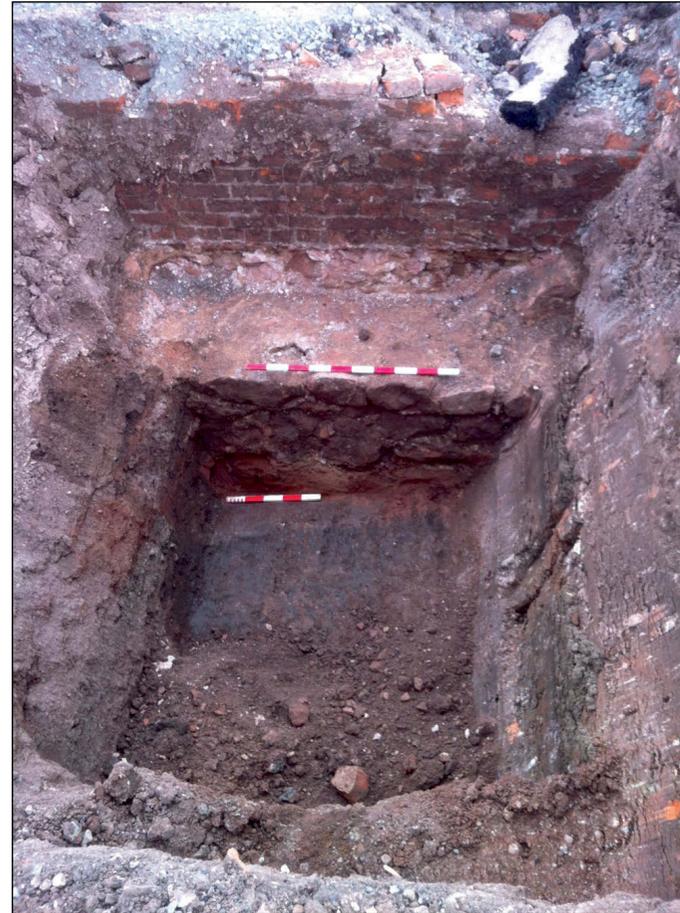
Plate 6: Medieval city wall **Trench 45**, west facing section of **4512**

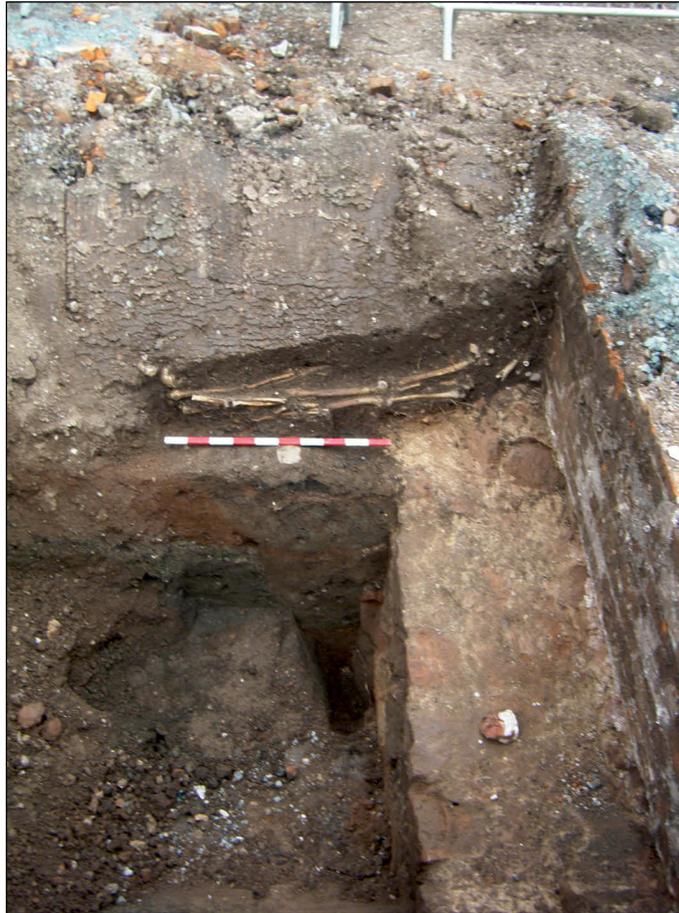
Plate 7: **Trench 45**, construction cut for medieval city wall **4512**

- 4.3.9 The primary construction cut (**4509**) for the foundation was filled with mortar layer **4515** upon which the city wall was constructed. The construction cut was then backfilled with brown silty sand **4510** which contained a small piece of heavily abraded Roman pottery at its base. The construction cut truncated natural grey clay **4508** which was recorded at a maximum depth of 2.8m bgl (16.35m aOD). A secondary construction cut was also recorded (**4513**) along with a secondary phase of backfilling (**4514**). The upper level of recut **4513** is at the same level as the stepping in of the city wall which indicates that this steeping-in related to a second phase of construction/repair to the original city wall structure.

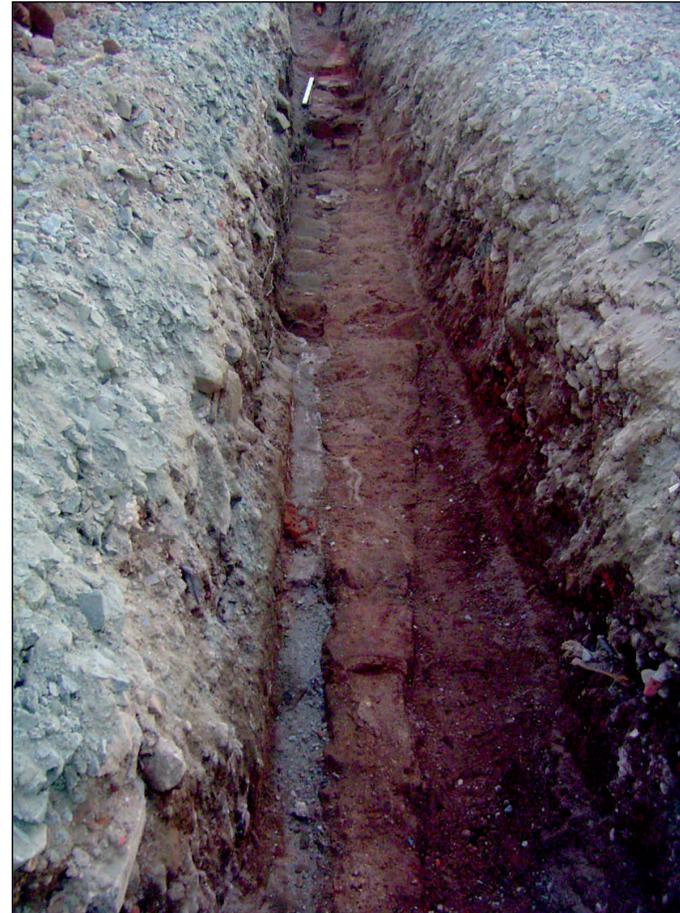
Plate 8: Medieval city wall **Trench 56**, west facing section of wall **5614**

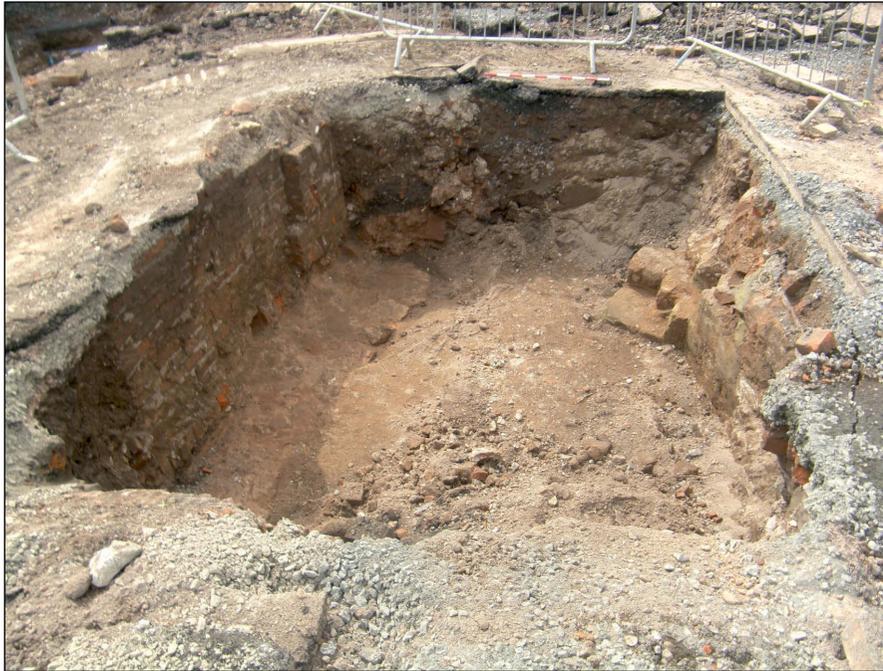
Plate 9: Buttress of medieval church **1506**, within **Trench 15**

4.4.1 **Trench 15** contained a Victorian church wall **1511** (see **Section 4.5.14**), which sat directly on top of a sandstone buttress **1506** (at a depth of 18.17m aOD), identified as the probable remains of the medieval church. A Red sandstone structure **1506** measured 0.7m by 0.7m and abutted the Victorian wall at a depth of 1m bgl (**Figure 4, Plate 9**). It seems likely that the medieval buttress was utilised as part of the foundation for the Victorian church. The medieval buttress and later Victorian structures was sealed by a former graveyard soil **1504**. Given this relationship it seems likely that within the locale of **Trench 15** the soil disturbed by the construction of the Victorian church was removed, and redeposited on Site once the Victorian church walls had been erected.

- directly on top of a sandstone buttress **1506**, identified as the probable remains of the medieval church which occupied the Site. Red sandstone structure **1506** measured 0.7m by 0.7m and abutted the Victorian wall at a depth of 1m bgl. It seems likely that the medieval buttress was utilised as part of the foundation for the Victorian church. The medieval buttress and later Victorian structures was sealed by former graveyard soil **1504**. Given this relationship it seems likely that within the locale of **Trench 15** the soil disturbed by the construction of the Victorian church was removed and redeposited on Site once the Victorian church walls had been erected. The reburied (but not previously analysed) skeletal remains of the Worcester Archaeology evaluation (2013) as well as additional human bones from deposit **1504** were analysed and prepared for reburial.

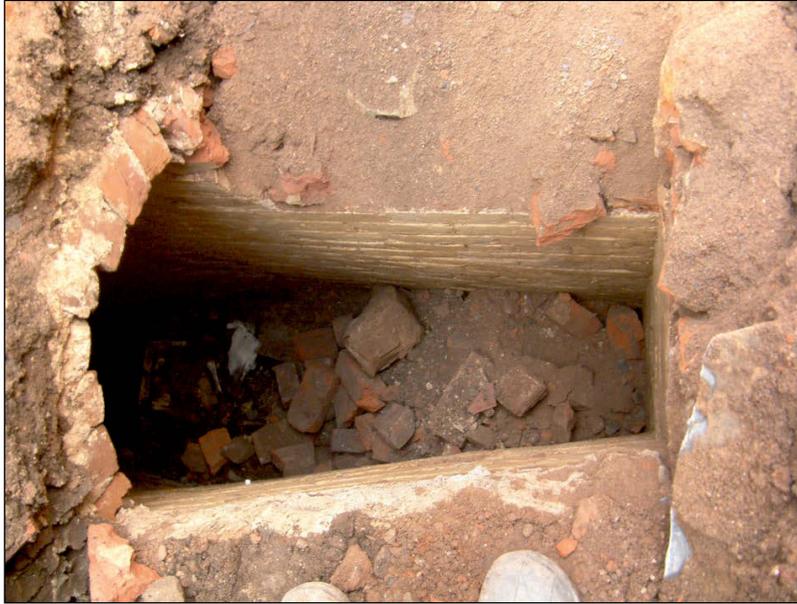
Plate 13: Vault **1005** within **Trench 10**

- 4.5.10 **Trench 10** again identified this same church flooring. Once removed an east-west aligned vault was found to be sealed by the concrete flooring. Vault **1005** consisted of a single skin of handmade, un-frogged red bricks, with the interior wall of the vault painted white (**Plate 13**). Vault **1005** was identified at a depth of 1.40m bgl and no skeletal remains or coffins were identified. The excavation was halted once the vault was uncovered due to safety concerns.

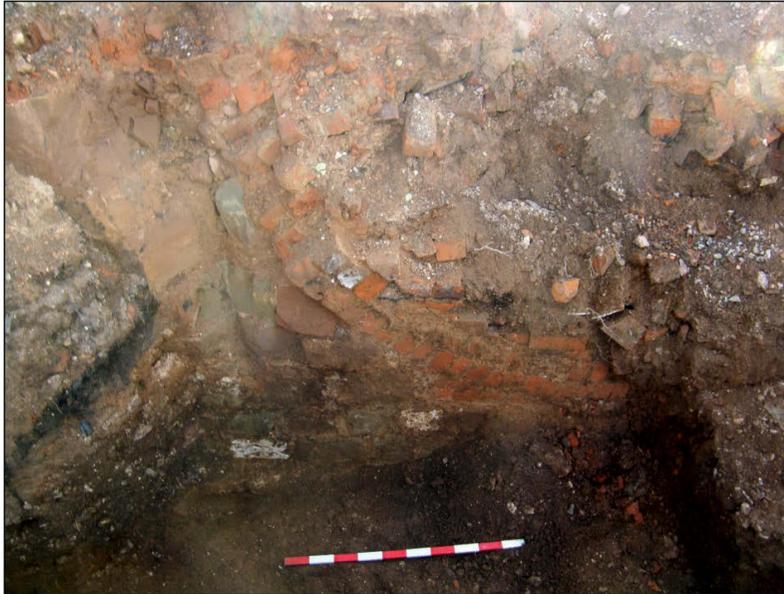
Plate 15: Victorian church wall **1606** within **Trench 16**

- 4.5.16 **Trench 16** identified the eastern wall of the Victorian church ( **Plate 15**). This was made up of sandstone foundation **1606** (= **2020**) and brick structures **1604** and **1605** (= **2021**). A red brick arch formed part of structure **1604** and was exposed immediately beneath the bedding material for the car park at a depth of 0.3m bgl (18.90m aOD). A layer of brown sand (**1603**) was identified abutting the exterior face of wall **1604-1605** and represented a medieval graveyard soil disturbed by the construction of the Victorian Church. Layer **1603** contained abundant human bone fragments and a human skull. Both the church wall and layer **1603** were excavated to a depth of 2.7m bgl 16.45m aOD). Excavation was halted at this depth as natural sterile clay **1607** was reached.

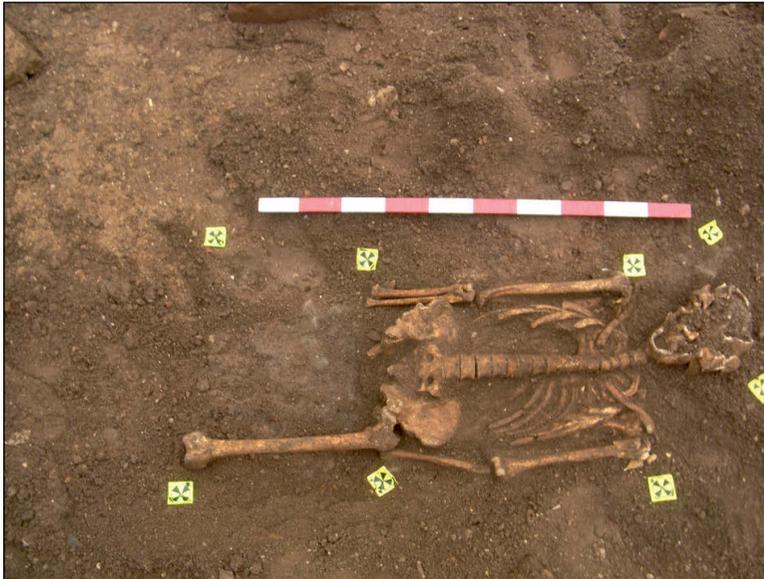
Plate 17: Skeleton **SK2001** within **Trench 20**

6.3.1 **Skeleton 2001:** 50% of a well preserved adult male aged 20 to 30 years. The skull, torso, pectoral girdle, upper limbs, pelvic girdle and left femur were in-situ, but the lower limbs were not present due to post-depositional disturbance. The left femoral length of 46.6cm provides an estimated stature of 172.3 cm  $\pm$  3.27. This individual exhibited dental caries on two teeth. No other pathological conditions were observed.

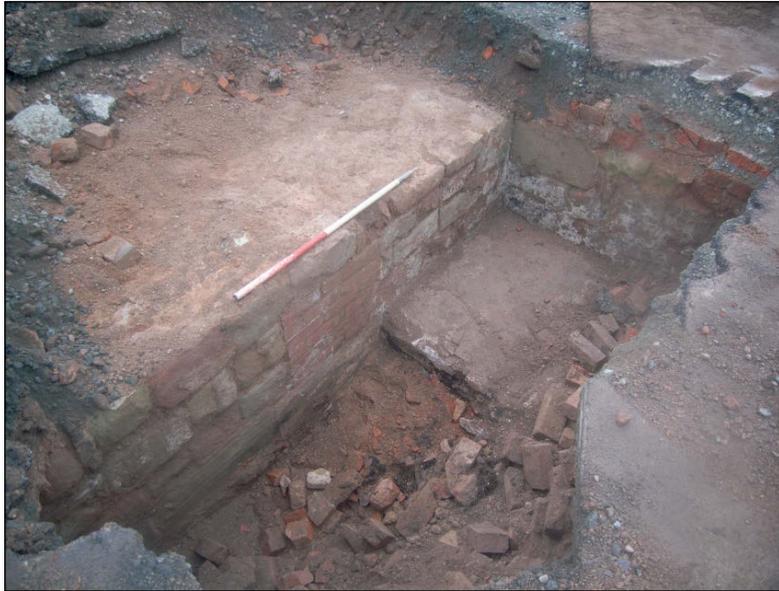
Plate 19: Structures **2111** and **2112** within **Trench 21**
